Facility Assessment

Fire Station Building #1

Prepared for
the City of Taylor Mill, Kentucky

January 5, 2021

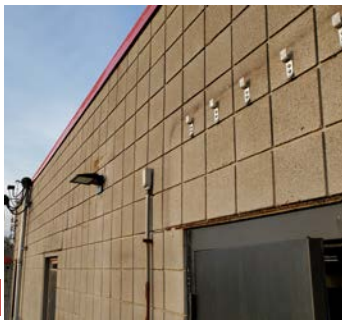
10

Steel lintels above the exterior doors and windows were observed to have a significant coating of rust (corrosion). See photos 10, 11, & 13. The expanded volume of these lintels has separated the mortar joint between the course below and course above the lintel extending around the structure, which allows water to get into the wall. In places, this separation is also observed from the inside.

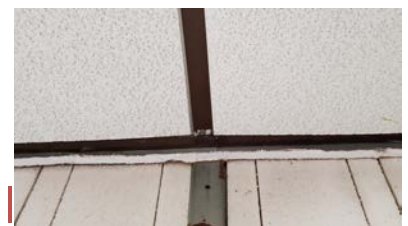
14

Additionally there is evidence of bowing in the east wall. This is visible on the outside between the door and the first window. On the inside of the Break Room, the ceiling edge angle moved with the wall's bowing and the perpendicular ceiling grids and tiles are pulling away. See photo 14. The white on the ceiling grid member indicates the edge angle has moved away from it. Therefore, we recommend connecting a steel angle to the exterior block wall and tying that back to several roof joists.

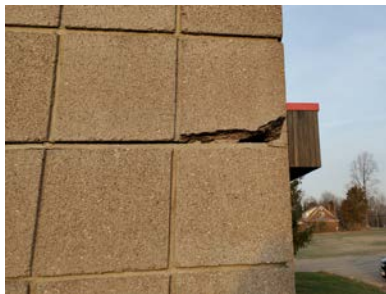
15

In a few locations, the brick is chipped or cracked. Inside corners exhibit separation. See photos below. The Apparatus Bays and the Office structure are separating above the upper floor line. Rust staining is visible in one area.

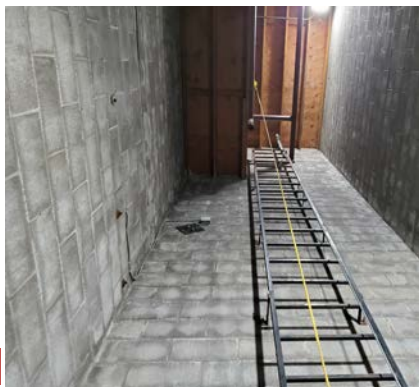
19

The Hose Tower exhibits significant efflorescence on the interior with some of the blocks moving horizontally towards the interior of the tower at various heights. The exterior shows buckling and bulging of the outer wythe. The west face is breaking away from the remainder as evidenced by cracks through a few blocks at the score line alternating with separation between the mortar and the adjacent block.

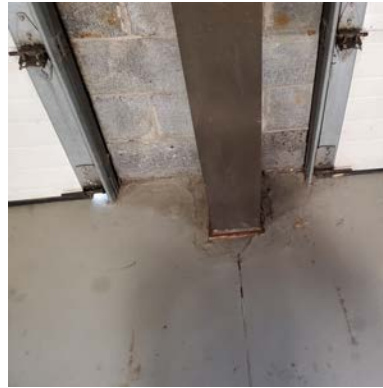
24

Condition: The Apparatus bays are in good condition. In three locations, deterioration of the lower two courses of concrete block were observed. See photo 24. These were near overhead doors where daylight was visible through gaps between the doors and frames at the base. This could allow moisture in the block to freeze and spall the inside surfaces.

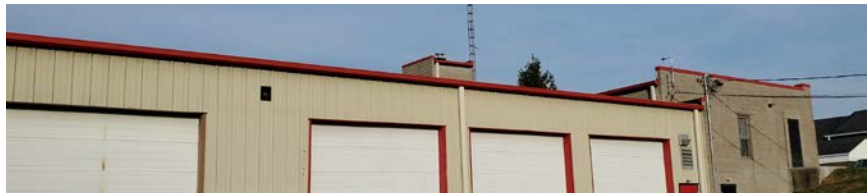
26

Condition: The entire building was re-roofed two years ago with EPDM membrane and metal fascia drip edge. No roof leaks have been reported since this work was completed.

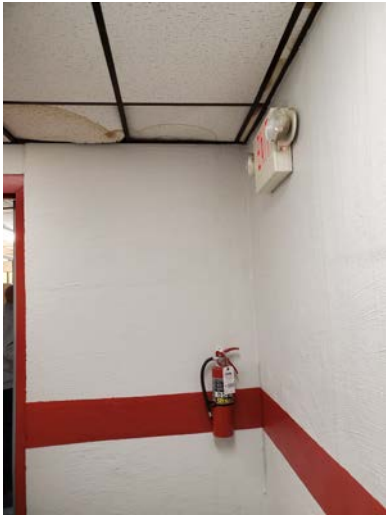
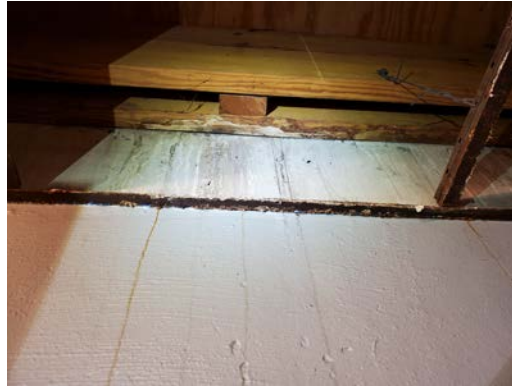
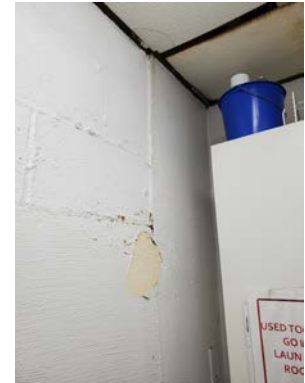
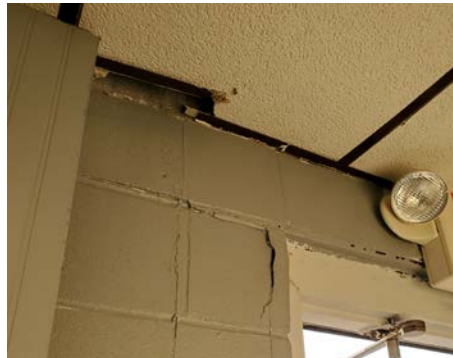
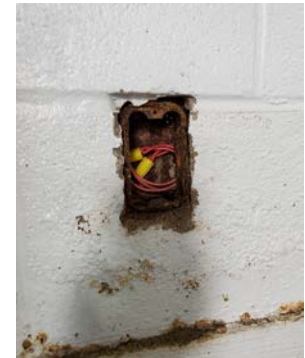
Water has been observed running down the concrete foundation wall under the front entry and pooling on the floor. Staining on the wall and some ceiling tiles remain. Water has rusted the ceiling grid in the Men's toilet room and staining on the wall remains. Water has blistered the paint on the Shower room wall, rusted the ceiling grid, soaked and bowed a ceiling tile. Spalling of the interior concrete block is evident. Device boxes in the exterior walls are severely rusted.

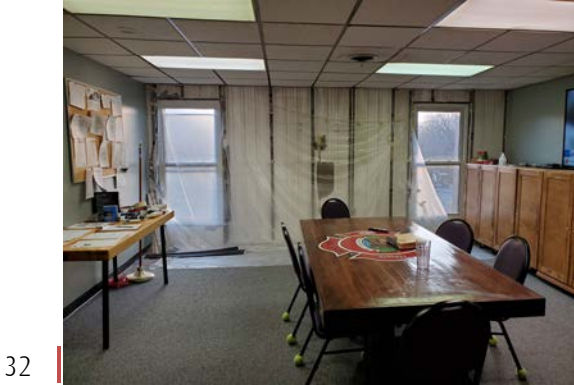
32

The finished drywall has been removed from the upper level Break Room exposing the insulation and rusted furring strips. The ceiling grid shows horizontal movement (bowing) of the exterior wall. Many other upper level rooms exhibit irregularities in the paint surfaces at the window returns, suggesting corroded corner beads. A few windows show cracks emanating from the upper corner of the window.

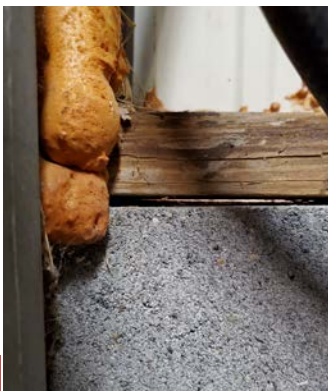
36

The condition of the Apparatus Bays is satisfactory. Light was observed between the wainscot and wall sole plate in one location and some of the wall insulation is damaged or missing. The concrete block separation wall between the Apparatus Bays and the current Fitness room is in good condition as is the insulation and firestopping sealant above the structural frame to the roof.
