TECHNICAL MEMORANDUM

TO: Sean Blake, P.E., Sanitation District No. 1 of Northern Kentucky

FROM: Richard W. Carr, P.E., Mason Carr Civil Engineering, LLC

RE: Vincent Drive, Taylor Mill, KY Drainage Improvements Technical Assistance

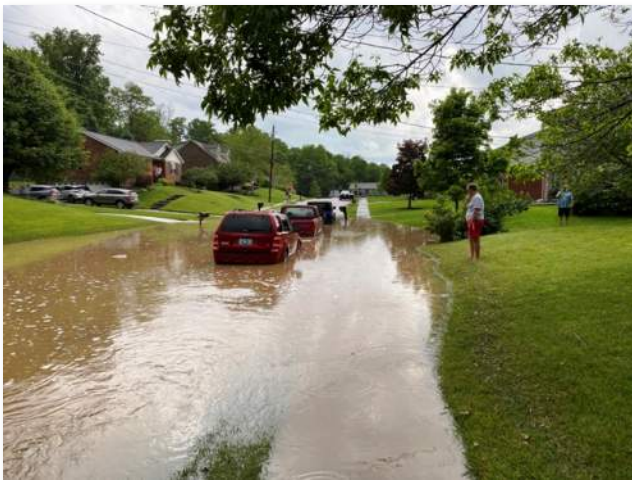
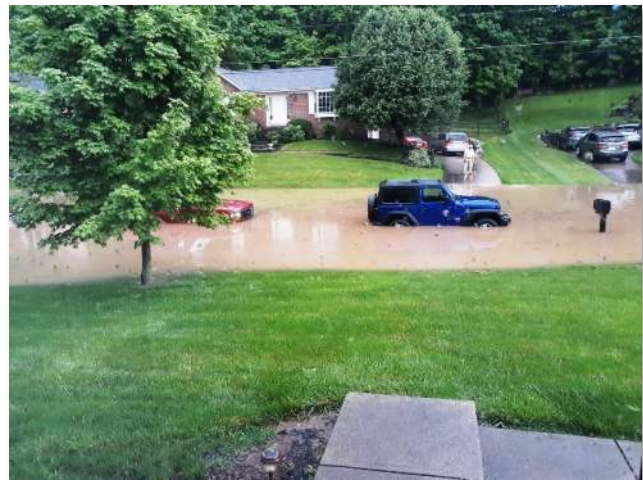
During recent storm events, there have been excessive flooding issues occurring at Vincent Drive located in Taylor Mill, KY. On May 24, 2020, one flooding event is pictured in Figure 1 as documented by the residents.

Figure 1 – Flooding at Vincent Drive in Taylor Mill, KY on May 24, 2020

The roadway flooding near 736 Vincent Drive is the result of several factors. The street grades and lot grading created a “sag” condition in the subdivision. The condition is worsened by upstream street drains allowing flows to pass-by due to resurfacing and pavement reconstruction. The direct drainage area into the “sag” is approximately 4.7 acres with over half of that from the uphill Heathermoor Subdivision. The total drainage area into the “sag” area is approximately 28 acres. During storm events in recent years, residents have reported flooding that has occurred on the street as deep as 18” for short periods. Residents indicate the flooding lasts for 5 to 10 minutes.

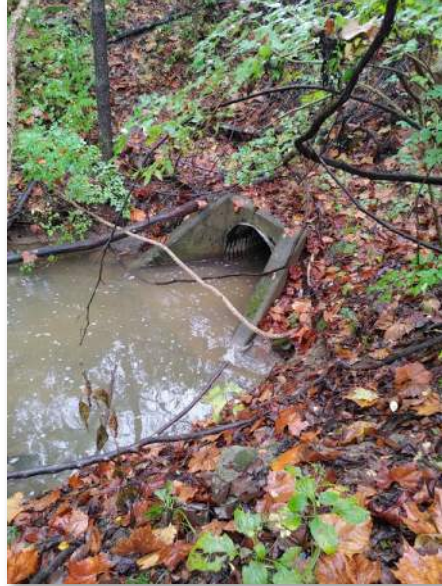
The total drainage area contributing stormwater flow to this location is 38.7 acres with 10.5 acres of that area being impervious surfaces. The drainage area that discharges into the creek at the bottom of the 748 Vincent Drive property discharges through the headwall pictured in Figure 3.

Figure 3 – Headwall at 748 Vincent Drive

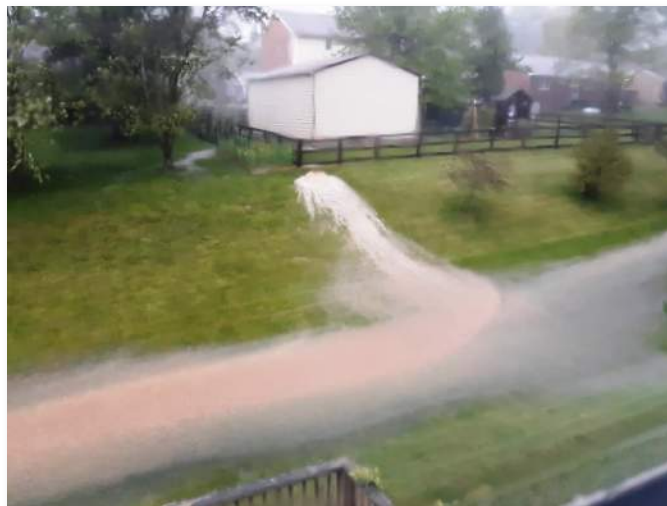
Figure 4 – Manhole #89 during a flooding event

The existing storm manhole in the back yard of 738 Vincent Drive has been reported to surcharge during storm events. The manhole rim is elevated and no surface flow enters at the manhole. The drainage

area upstream is approximately 6.8 acres of single family homes and street. The pipe of this manhole is a shallow 15" PVC at a rather steep slope of 18.8%.

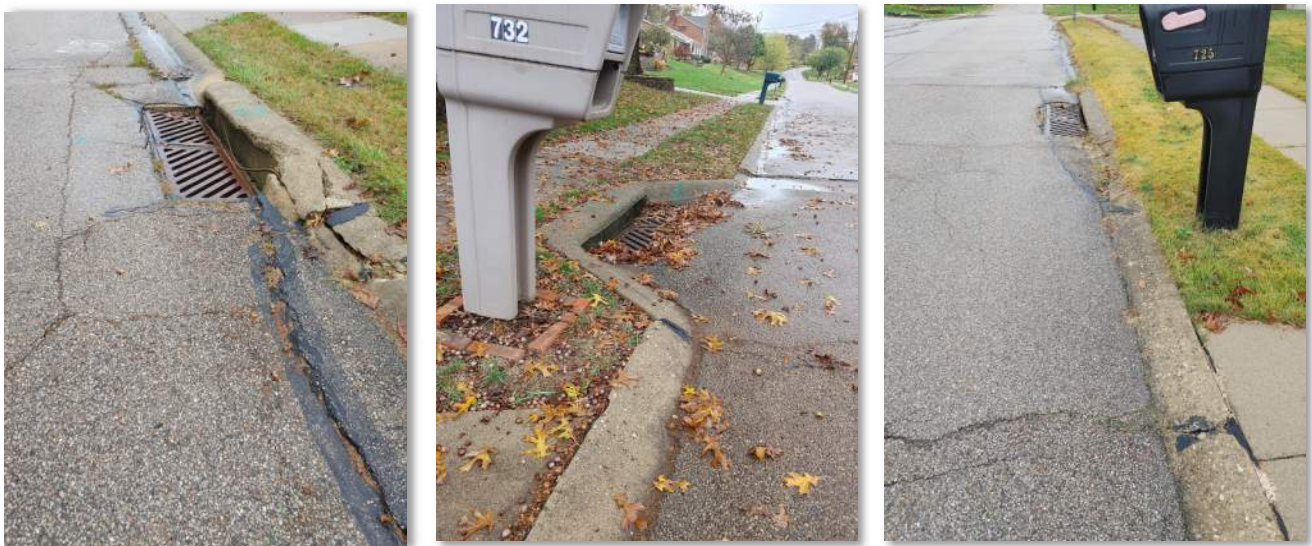
From the manhole in the east side yard of 740 Vincent Drive, the pipe extends out to Vincent Drive including 170 LF of 36" corrugated metal pipe along Vincent Drive to a manhole directly in front of 736 Vincent Drive at which point the pipe transitions to a 24" Reinforced Concrete Pipe. Several curb inlet catch basins along Vincent Drive collect stormwater that discharges into this 24" RCP. There is 559 LF of 24" RCP that transitions to a 15" Reinforced Concrete Pipe at a catch basin directly in front of 724 Vincent Drive near the intersection of Bonnie Drive and Vincent Drive. Subsequent repaving of the street on Vincent Drive over the course of its lifetime has caused the pavement thickness to increase, which effectively reduces the capacity of the curb and gutter system to be able to collect stormwater flows as pictured in Figure 5. This section of Vincent Drive is also part of a natural "sag" area of the street where stormwater has no way out. This is the location indicated in Figure 1 which is the main location of the extreme flooding conditions.

Figure 5 – Curb inlets along Vincent Drive

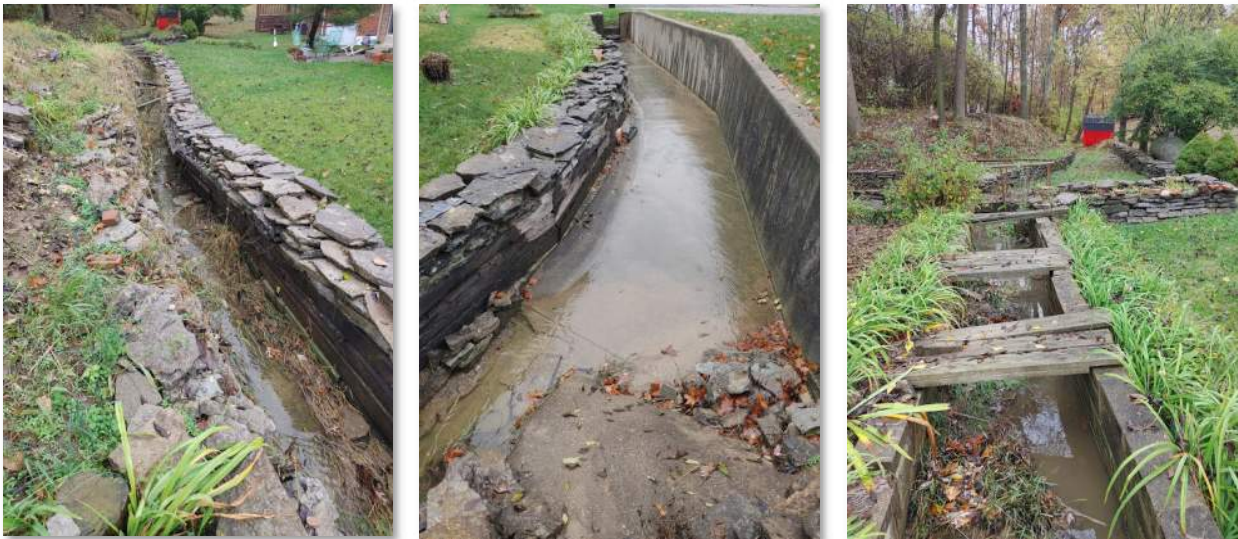
Figure 6 – Paved, rock-lined channel behind 716 and 718 Vincent Dr

The existing natural stream behind 716 Vincent Drive and the masonry channel behind 718 Vincent Drive drain an area of approximately 11.1 acres. The existing KY-16 right-of-way (4.8 acres) is directed into a retention basin at the southwest side of the Wayman Branch and KY-16 intersection. Although no design criteria are available from the Kentucky Transportation Cabinet, the riser discharge system seems to effectively regulate runoff. The Right-of-Way retention basin discharges to a natural creek via a 24" pipe. Additionally, 1.7 acre of Right-of-Way and woodland drain into that creek. A private driveway to the cemetery crosses that creek. Based on field observations, it appears there is a pipe of unknown size and depth buried under that driveway. The existing creek behind 716 Vincent Drive has a drainage area of approximately 11.1 acres. The creek overflows the banks causing water to flow into the basement of 716 Vincent Drive. The existing masonry channel behind 718 Vincent Drive is approximately 24" wide x 30" deep x 100' long at 2% slope. This channel is in a state of disrepair due to movement in the side walls and general lack of maintenance. Over time sediment has built up and the creek no longer has much definition. In addition, several issues cause impediments to the flow of the creek, which may cause the flow to jump out of the creek including debris, the walking bridge behind 718 Vincent Drive, and the storage shed that was built in the creek behind 716 Vincent Drive. When flow exceeds the capacity of the channel, water flows toward the house.

- Constructing a new ditch behind 716 and 718 Vincent Drive (approximately \$58,000),
- Installing a new 24” PVC storm sewer parallel to the existing rock channel from the new ditch to the catch basin in Vincent Drive near the southwest corner of 718 Vincent Drive. The new pipe would be located between the existing rock channel and the house at 718 Vincent Drive (approximately \$36,000)

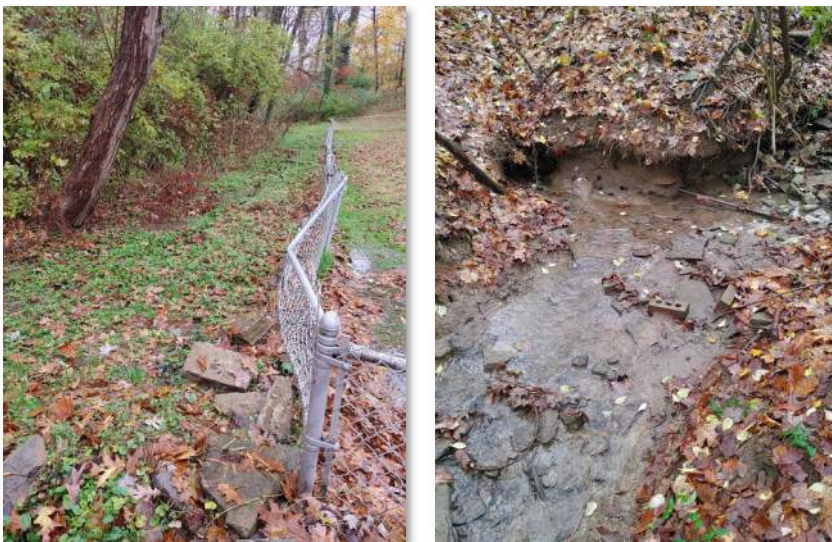
At this point, the paved channel transitions to a grass swale for another approximately 200 LF to a private culvert through a crossing to a private cemetery that uses this access from Vincent Drive. Upon Mason Carr’s site visits, this culvert was buried, so for this purposes of this study, Mason Carr and SD1 staff determined the best course of action was to proceed as though the culvert is not there.

Figure 7 – Grass swale behind 714 Vincent Drive

- Constructing a new ditch behind 714 and 716 Vincent Drive (approximately \$36,000),
- Installing a new 24" PVC storm sewer along the property line between 716 and 718 Vincent Drive from the new ditch to a new catch basin at Vincent Drive and then along Vincent Drive to the catch basin directly in front of 724 Vincent Drive (approximately \$68,000)

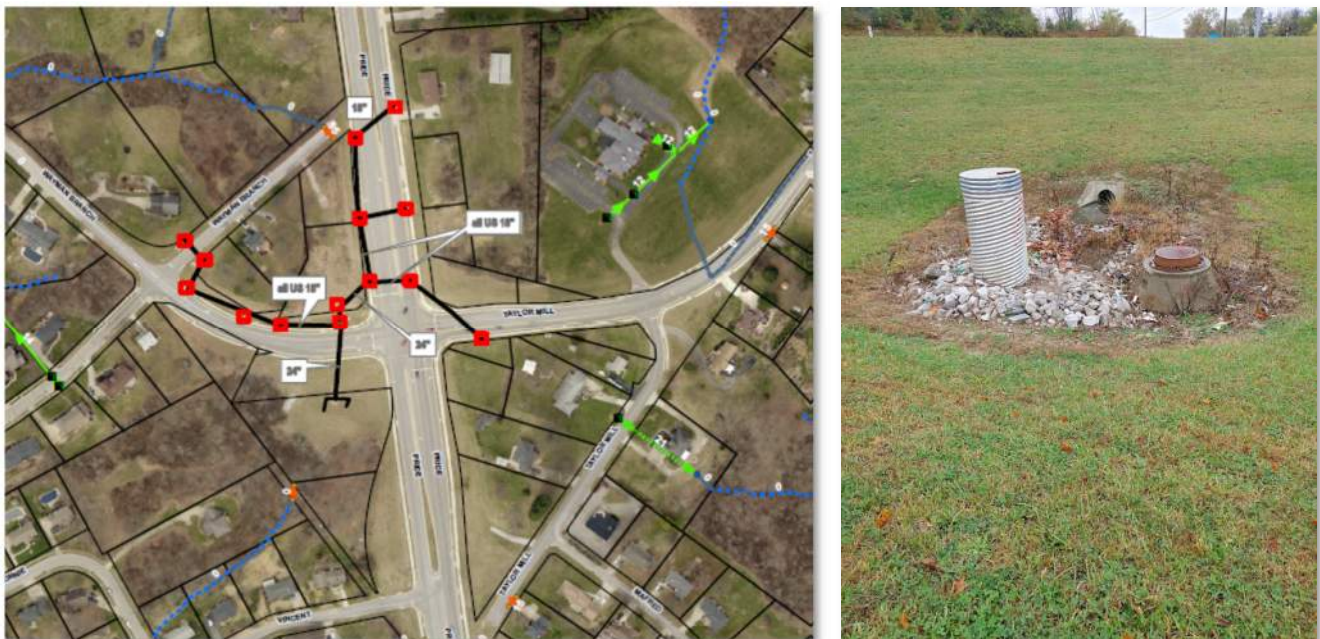
Stormwater flows into the grass swale from the existing grated headwall, which is the outfall from the retention pond built in the right-of-way in the intersection of Wayman Branch Rd and Pride Parkway. Upon review of the Kentucky Transportation Cabinet drainage folder for the construction of Pride Parkway, it was determined that this retention pond was added after the fact in the design process and

therefore does not have any applicable design parameters/calculations. For the purposes of this study, no additional field measurements were taken to determine the effectiveness of the retention. Upon investigation, it did appear that the retention area was being maintained, and that was confirmed by Mr. Brian Haney during our initial site visit. Upon request, SD1 staff did map out the storm piping system associated with this retention pond and provided the schematic of the system as shown in Figure 8. There appears to be a 24" corrugated metal riser section that acts as the control structure for this retention area effectively controlling the outfall to the grated headwall at the base of the pond. This retention area appears to hold back a significant amount of flow, which is then allowed to slowly discharge by way of the 24" corrugated metal riser control structure.

Figure 8 – Wayman Branch and Pride Parkway Intersection Retention Area

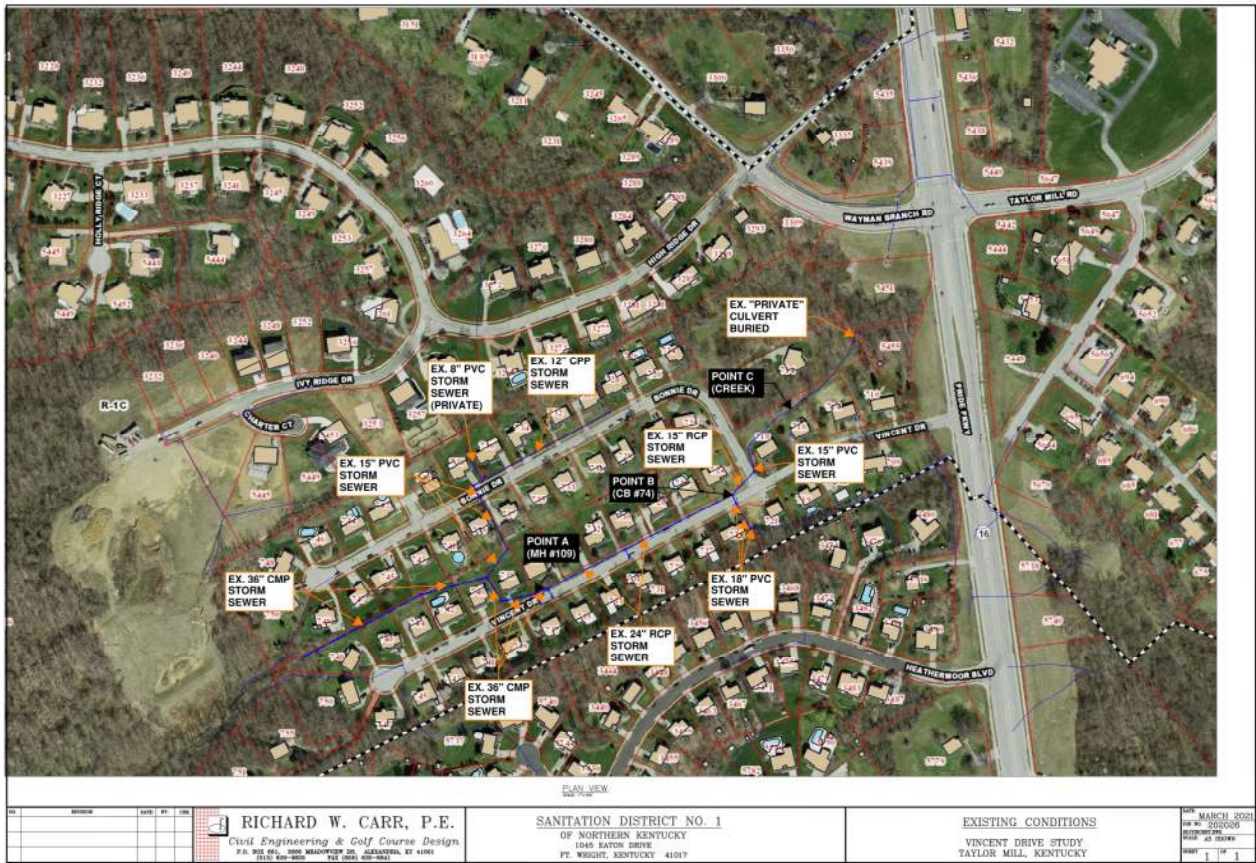
- Point A – location of manhole in Vincent Drive near the lot line between 738 and 736 Vincent Drive in the existing “sag” area of Vincent Drive
- Point B – location of catch basin directly in front of 724 Vincent Drive near the intersection of Vincent Drive and Bonnie Drive
- Point C – location of Existing Creek behind 716 Vincent Drive

Figure 9 – Existing Conditions and “Control” Points Map

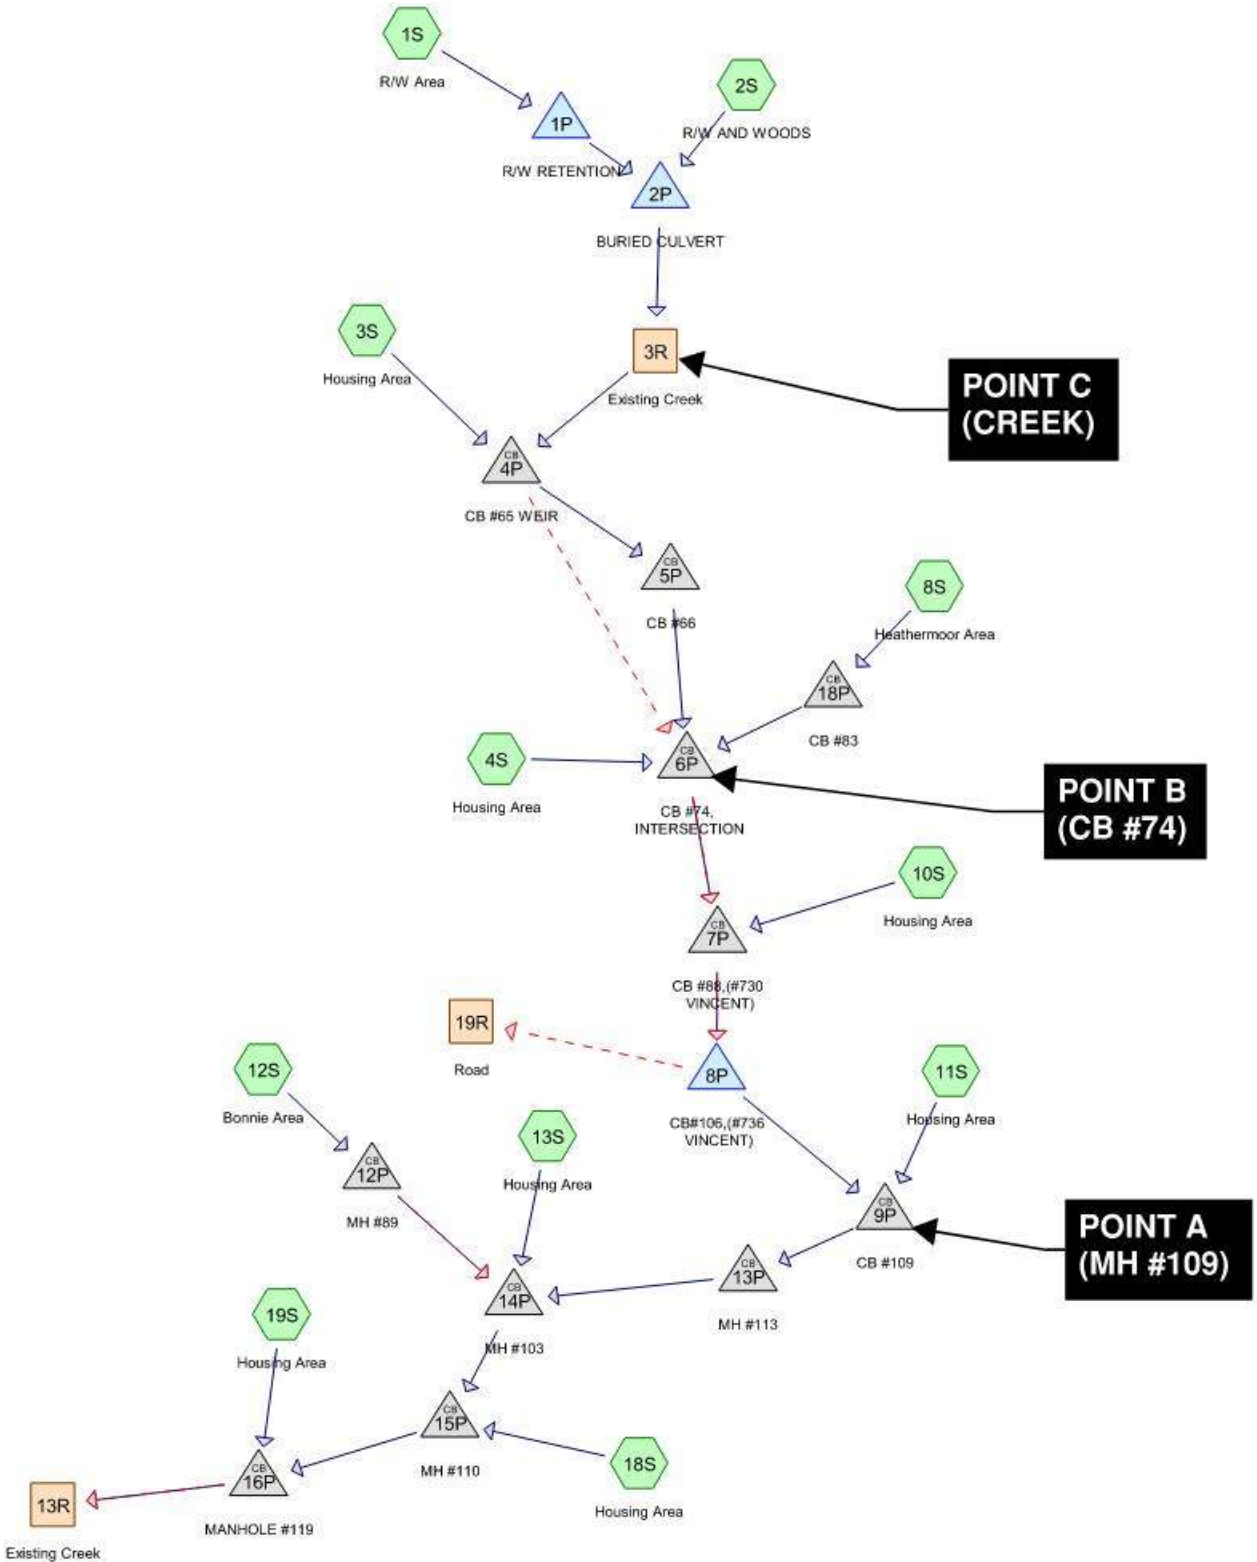
Figure 10 – Diagram of Stormwater Model – Existing Conditions

The stormwater model referenced above in Figure 10 was used to analyze the existing conditions and the overall capacity of the existing storm sewer system in the area designated for this study. It appears that the existing storm sewer system does not have enough capacity to properly manage the storm water runoff associated with the design storms that were evaluated. Based on the stormwater model, most of the nodes demonstrated approximately a 5 year level of service with a couple of nodes demonstrating less than a 2 year level of service. Table 3 below summarizes the maximum water depths for the existing conditions at each of the “control” points established earlier in this report. The values in Table 3 represent the elevation of the Hydraulic Grade Line (HGL) minus the rim elevation of the corresponding storm structure (or the floor elevation of the nearby houses in the case of Point C). Thus, a positive value corresponds to a flood condition; whereas, a negative value corresponds to the water level being below the flood condition.

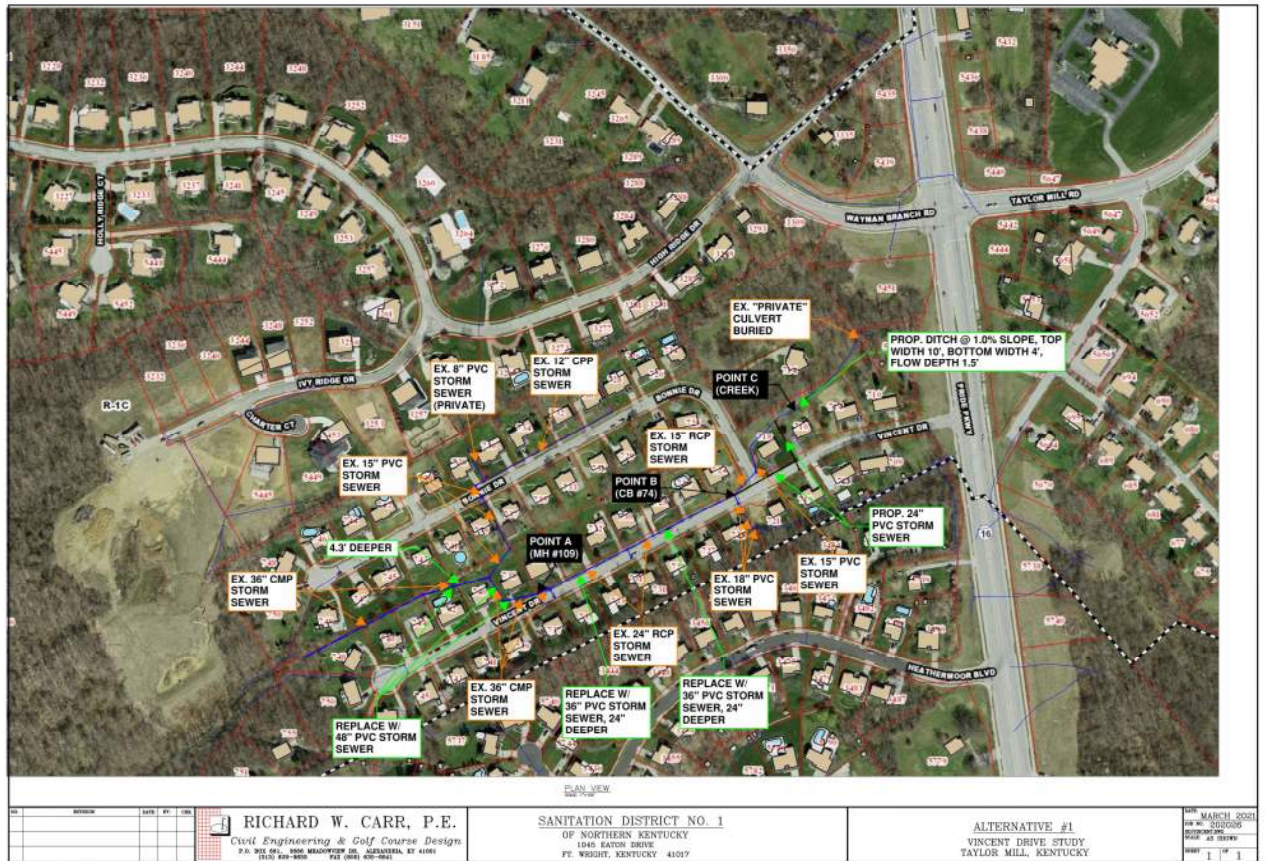
Figure 11 – Alternative #1 Map

- Upsizing to a 36" PVC Storm Sewer between the catch basin directly in front of 724 Vincent Drive and the catch basin directly in front of 736 Vincent Drive (this pipe would be 24" deeper than the existing pipe at the catch basin directly in front of 724 Vincent Drive) (approximately \$117,000)

- Upsizing to a 48" PVC Storm Sewer from the manhole in Vincent Drive near the intersection of the lot lines of 738 Vincent Drive and 736 Vincent Drive to the manhole in the backyard of 744 Vincent Drive (approximately \$71,000)

- Deepen the manhole in the backyard of 740 Vincent Drive by 4.3 feet on the downstream side. (approximately \$9,000)

The total planning level opinion of probable cost for this alternative is \$301,000. Exhibit D provides the full detail of the opinion of probable cost, and it is attached at the end of this report. Figure 11 below shows the improvements suggested for Alternative 1. Exhibit B is the full size 11x17 version of Figure 11, and it is attached at the end of this report.

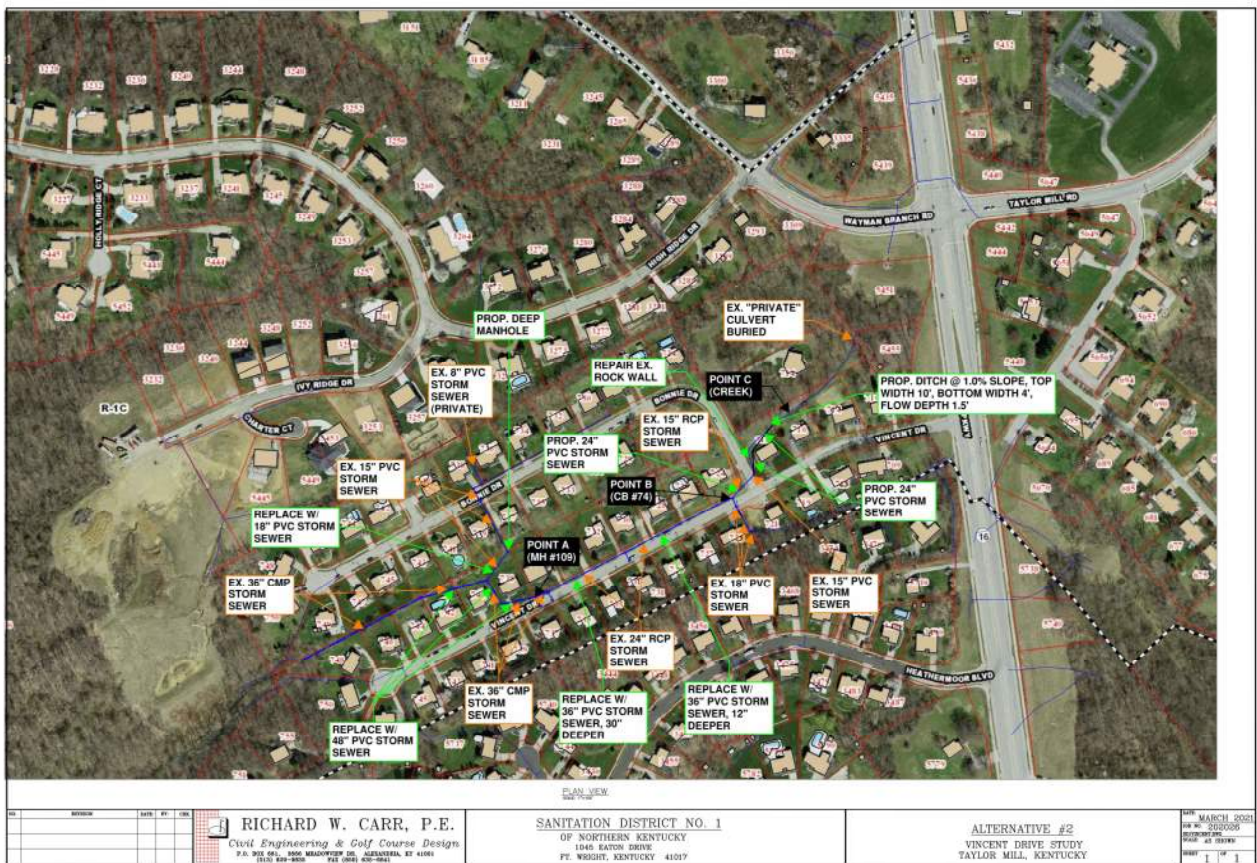
Figure 13 – Alternative 2 Map

- Upsizing to 24” PVC Storm Sewer from the catch basin in Vincent Drive near the southwest corner of 718 Vincent Drive to the catch basin directly in front of 724 Vincent Drive (approximately \$20,000)

- Upsizing to a 36” PVC Storm Sewer from the catch basin directly in front of 724 Vincent Drive to the catch basin directly in front of 730 Vincent Drive (this pipe would be 12” deeper than the existing pipe) (approximately \$59,000)

- Upsizing to a 36” PVC Storm Sewer from the catch basin directly in front of 730 Vincent Drive to the manhole directly in front of 736 Vincent Drive (this pipe would be 30” deeper) (approximately \$48,000)

- Upsizing to a 48” PVC Storm Sewer from the manhole in Vincent Drive near the intersection of the lot lines of 738 Vincent Drive and 736 Vincent Drive to the manhole in the front side yard between 740 and 738 Vincent Drive (approximately \$23,000)

- Upsizing to a 48” PVC Storm Sewer from the manhole in the front side yard between 740 and 738 Vincent Drive to the manhole in the back side yard between 740 and 738 Vincent Drive (approximately \$20,000),

- Upsizing to a 48" PVC Storm Sewer from the manhole in the back side yard between 740 and 738 Vincent Drive to the manhole in the backyard of 744 Vincent Drive (approximately \$45,000)
- Upsizing to a 18" PVC Storm Sewer from the manhole in the back yard of 738 Vincent Drive to the manhole in the back side yard between 740 and 738 Vincent Drive (the manhole in the backyard of 738 Vincent Drive would need to be deepened) (approximately \$12,000)

The total planning level opinion of probable cost for this alternative is \$321,000. Exhibit D provides the full detail of the opinion of probable cost, and it is attached at the end of this report. Figure 13 below shows the existing storm sewer system along with the improvements suggested for Alternative 2. Exhibit C is the full size 11x17 version of Figure 13, and it is attached at the end of this report.
