Mechanical, Electrical, and
Plumbing Condition Assessment
of the City of Taylor Mill,
Fire Station Building #1

Prepared for
CT Consultants, Inc.

January 2021

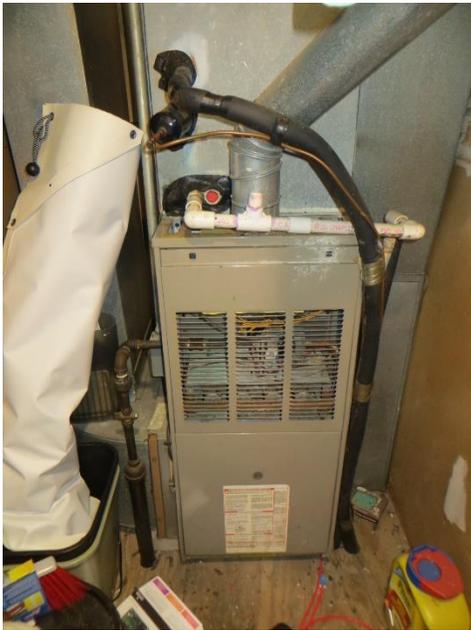
Figure 2 - Split-System AHU located on Upper Level

Tag	Mfr.	Model	Year	Years Remaining	Condition
AHU-1	Goodman	GMP100-4	1995	0	Fair
AHU-2	York	WHMM022355	2003	0	Fair

- a) **Air Handling Units / Condensing Units:** The AHU / CU equipment is operational, however, the age of the equipment is either at or past ASHRAE’s median service life expectancy. Furthermore, the existing units utilize R-22 refrigerant, which has been phased out of U.S. production starting in 2020. Obtaining this refrigerant for any potential repairs will become increasingly expensive as the available refrigerant supply depletes until it is no longer available.

The useful service life expectancy of both the air handling units / furnaces and the air-cooled condensing units have been exceeded. It is recommended that the equipment be inspected by a qualified HVAC contractor and suggest that the city administration consider a planned replacement of the equipment before failure occurs.

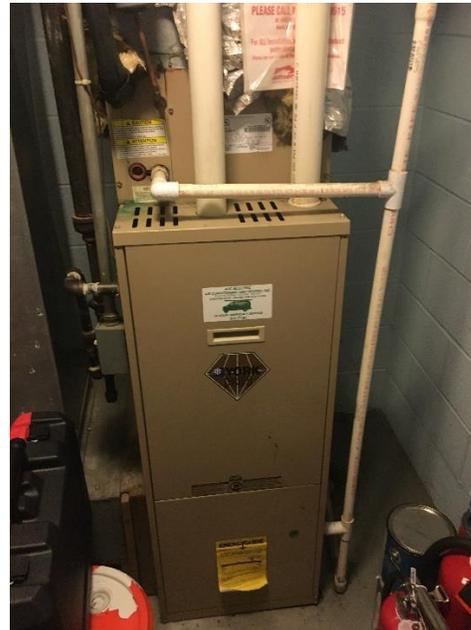
Figure 3 - Split-System AHU located on Lower Level

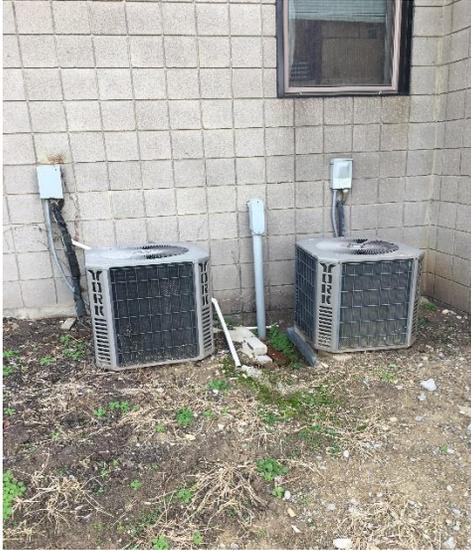
Figure 4 - Split-System AC Condensing Units

Tag	Mfr.	Model	Year	Years Remaining	Condition
CU-1	York	H4DB036S06A	2005	0-1	Fair
CU-2	York	H4DB036S06A	2003	0	Fair

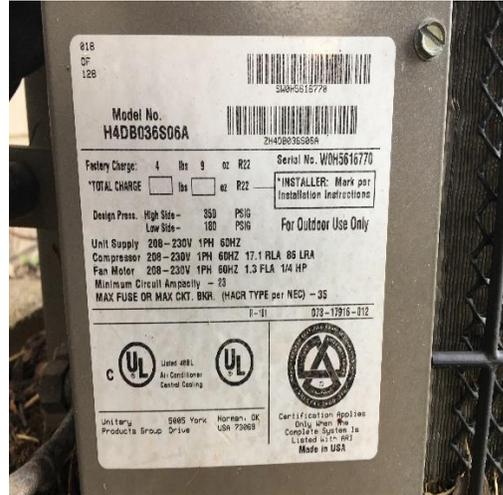
Figure 5 - Split-System AC Condensing Unit Tag (R-22)

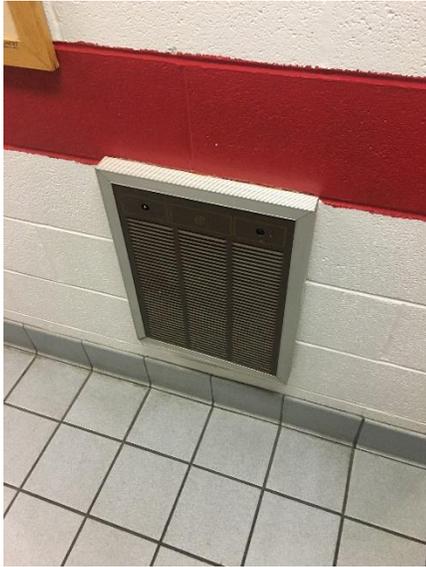
Building personnel noted that the existing wall heaters have not been in operation for some time. The age of the equipment was not readily apparent, however, they appear to original to the building.

Figure 6 - Electric Wall Heater located on Lower Level

The heaters were all off and operation could not be confirmed. Also, if the heaters were installed when the building was constructed, then the useful service life expectancy of the equipment has been exceeded. It is recommended that the equipment be inspected by a qualified electrical contractor and suggest that the city administration consider a planned replacement of the equipment.

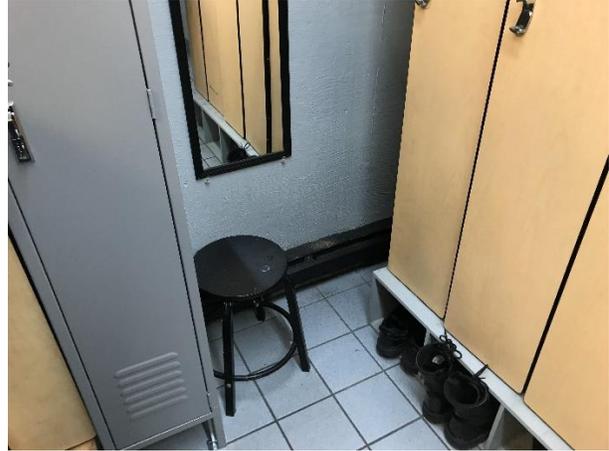
Figure 7 - Baseboard Heater located in Lower Level Men's Locker Room

Additionally, the electric baseboard heater in the lower-level Men's Locker Room has been turned off due to building water infiltration on the wall on which it is mounted. In addition to the potential equipment damage, the structural water infiltration creates an unsafe condition as it pertains to electric-powered heat.

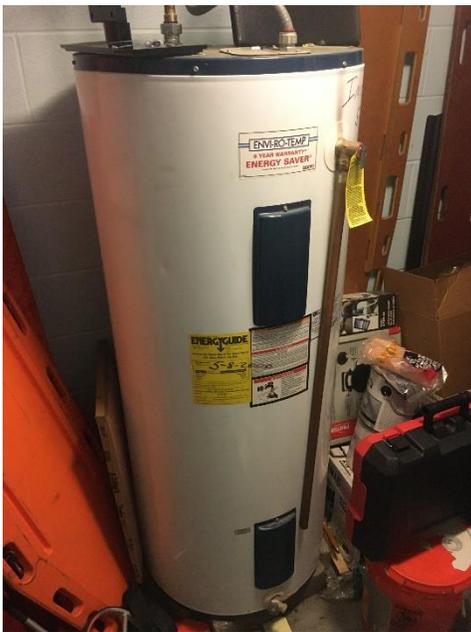
Figure 8 - Water Heater located in Lower Level Furnace Rm.

Tag	Mfr.	Model	Year	Years Remaining	Condition
DWH-1	US/Craftmaster	E2F80HD045V	2000	0	Fair
DWH-2	Bradford White	M280R6DS-1NCWW	2009	0-2	Fair

- a) **Domestic Water Heaters:** The typical useful service life expectancy of electric water heaters is eight to twelve years. So, based upon the heater manufacturing and installation dates, both of the heaters are past or nearing the end of their expected service life.

It is recommended that the equipment be inspected by a qualified plumbing contractor and suggest that the city administration consider a planned replacement of the equipment before failure occurs.

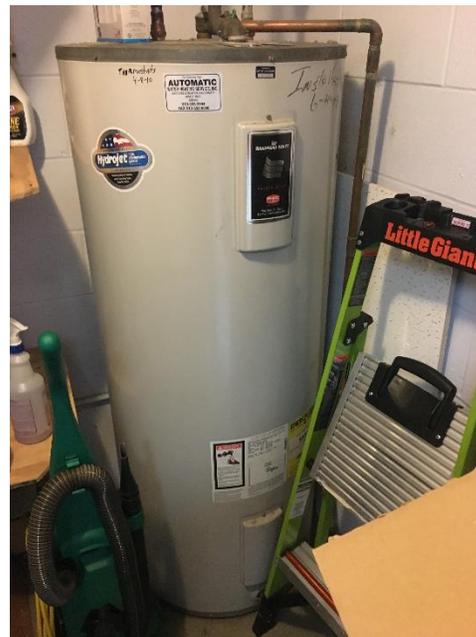
Figure 9 - Water Heater located in Lower Level Janitor Closet

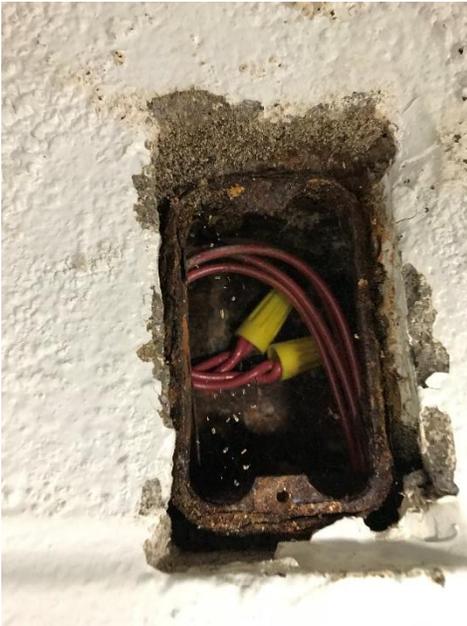
Wiring Devices: Wiring devices include general switches, receptacles, etc. The majority of the wiring devices are in fair to poor condition, many of which appear to be original to the buildings. Some wiring devices, or at least their outlet boxes, have sustained some water damage from past roof leaks.

Figure EP1 - Example of aging/water damage

- a) **General Conditions:** All existing electrical work should be inspected in detail to determine and document the true degree of damage that may have been caused from roof leaks over time. Any conditions that still warrant repairs or replacements should be addressed.

- f) **Wiring Devices:** Each wiring device should be inspected for integrity and proper ratings. Those that are found defective, overly-aged, water damaged, underrated, etc. should be replaced with properly rated specification-grade devices and new cover plates suitable for the respective environment. Any defective outlet boxes should be replaced when found.

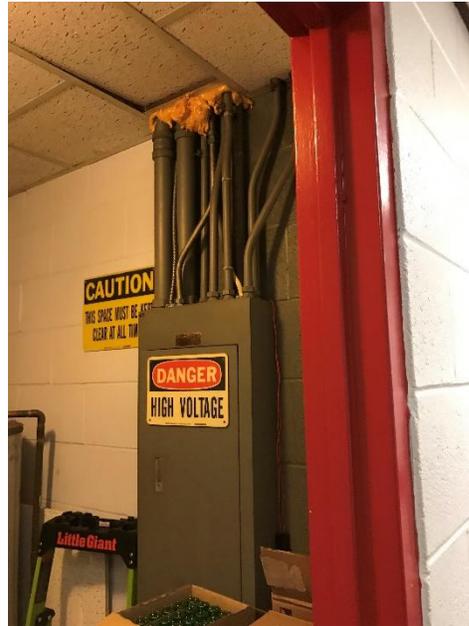
Figure EP2 - Example of trying to mitigate water damage

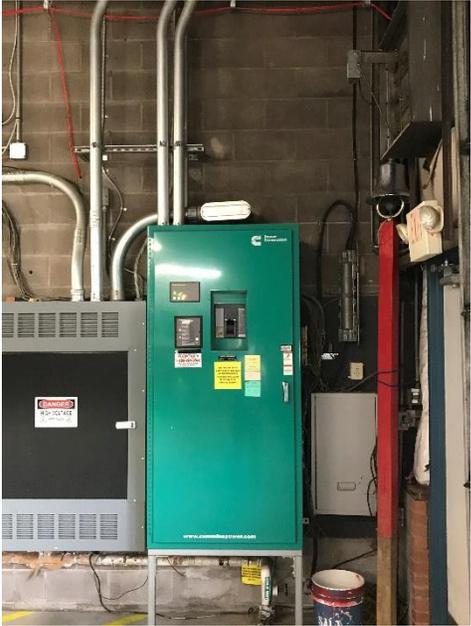
Figure EP6 - ATS and main distribution panel

- c) **Electric Standby Power Service:** The standby generator system appears adequate for current needs. Action should be taken to protect the automatic transfer switch and the adjacent power distribution panel and panelboard from serious water damage in the event a leak occurs at the valve or in the piping. The standby generator system may need to be expanded in the future if significant electrical loads are added. If the city outgrows the capacity of the generator over time, service and generator upgrade work will be needed. One option may be to dedicate the generator to the Fire Station and provide dedicated generators for the two other buildings. Another option may be to serve the Fire Station and Public Works buildings with the existing generator and provide a new generator for the City/Police building. The future load profiles will largely dictate the appropriate solution.

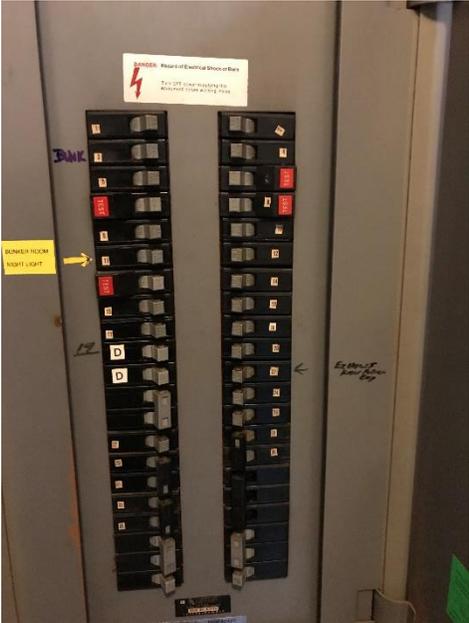
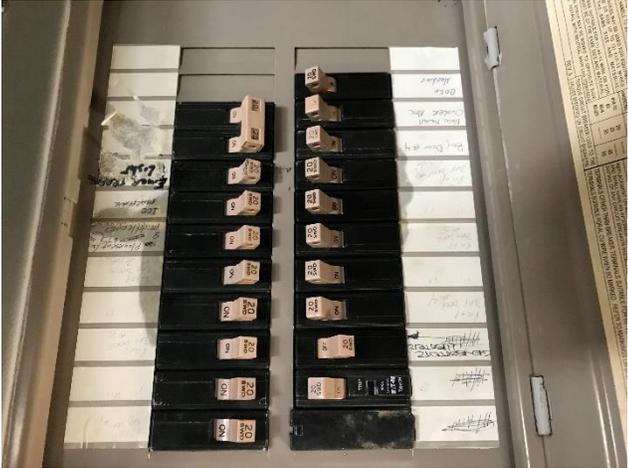
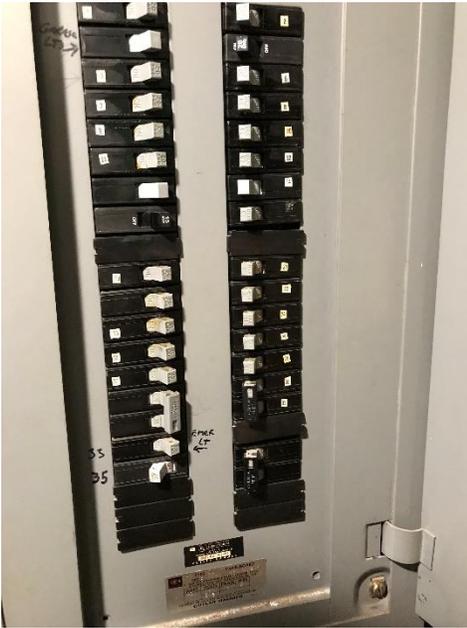
Electric Power Distribution: Electric power is distributed from the main power distribution panel (next to the ATS) to various smaller circuit breaker panelboards. Most of the downstream residential/light commercial grade panelboards are decades old and may not be rated to withstand the available utility fault current. Such ratings ensure breakers will trip when there is a short circuit condition faster than the inrush current will damage or destroy them.

Figure EP7 - Example of existing panelboard

Figure EP8 - Example of existing panelboard

Figure EP9 - Example of existing panelboard

- d) **Electric Power Distribution:** An electric Power Distribution Study should occur. Included would be developing a true as-built technical single-line diagram that shows how power is distributed and at what loads and ratings. Also included should be a Fault Current report that will identify which panelboards are and are not properly rated to withstand a fault (short circuit) with circuit breakers expected to successfully operate. Some or all of the panelboards downstream from the main distribution panel should be replaced based on general age/condition and based on the outcome of the Power Distribution Study.

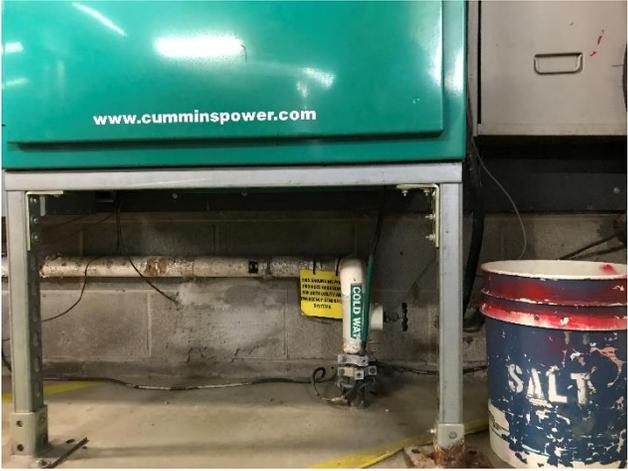
Figure EP10 - Water service entrance beneath Generator ATS

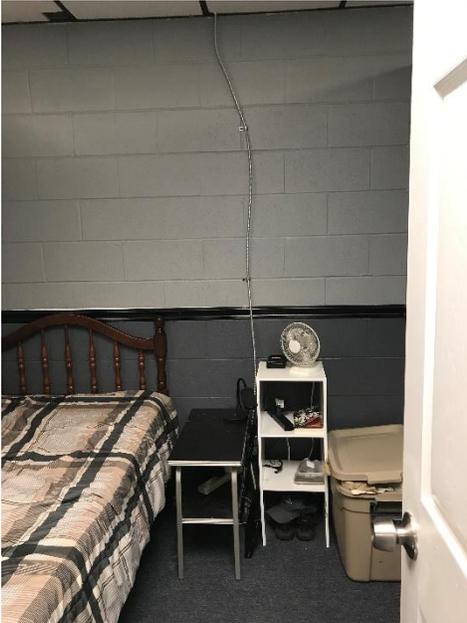
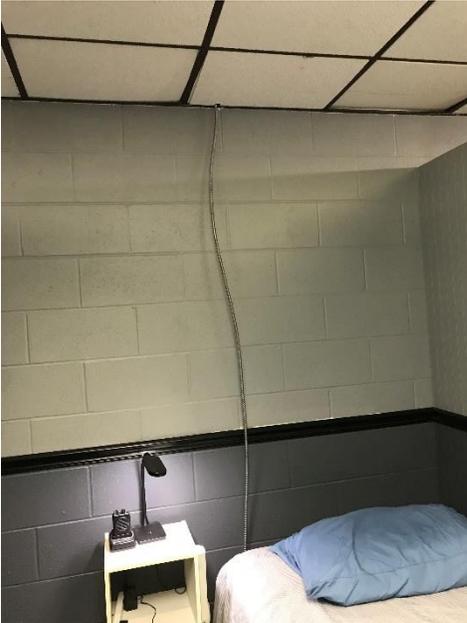
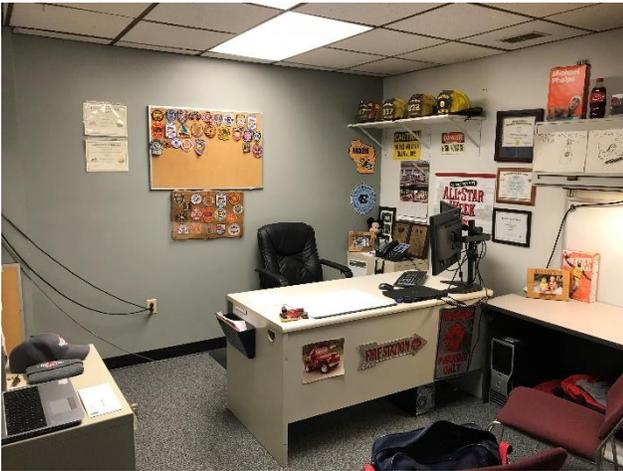
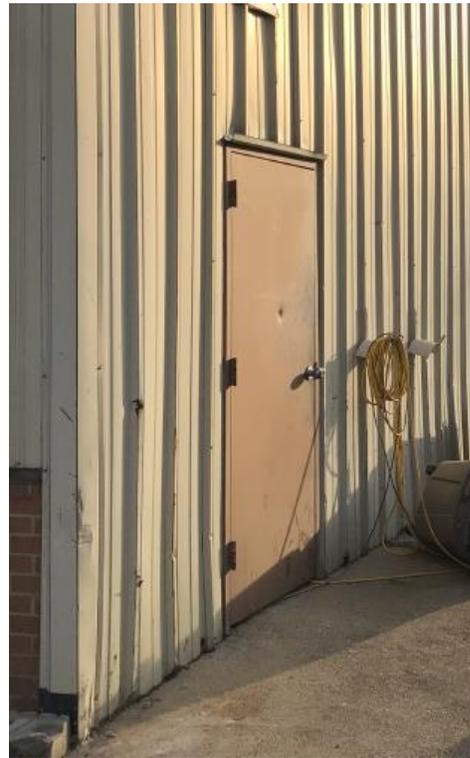
Figure EP11 - Example of outgrowing receptacle quantities

Figure EP12 - Example of outgrowing receptacle quantities

Figure EP13 - Example of outgrowing receptacle quantities

Figure EP14 - Example of outgrowing receptacle quantities

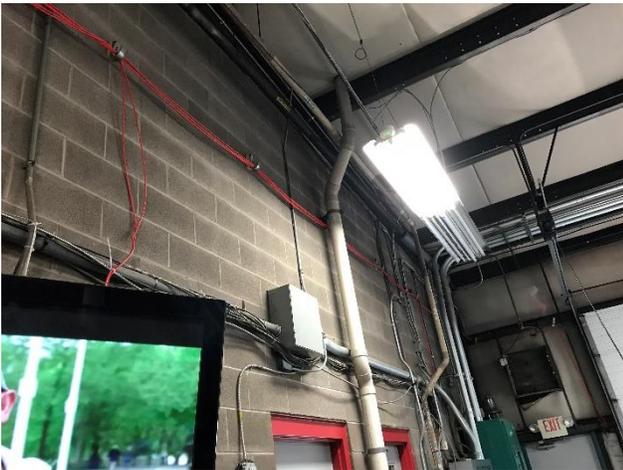
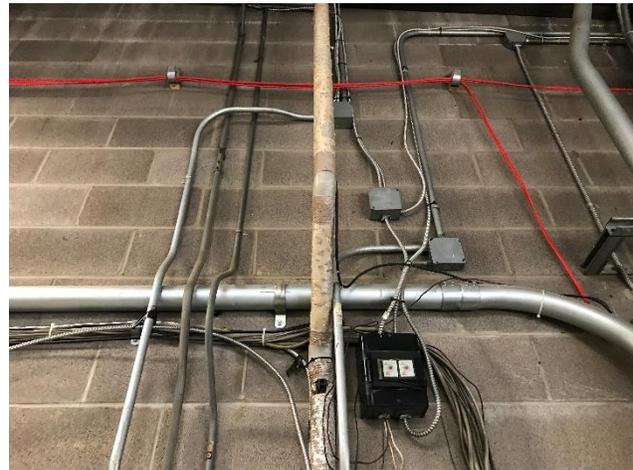
Branch Circuit Wiring and Cabling: The programmatic needs of the fire department have greatly outgrown the originally installed electrical branch circuiting. Electrical work has been added over time to keep up with evolving needs. Some of this added work was installed in a manner non-compliant with prevailing codes. Many of these instances involve means and methods used for installing cables (i.e.

improper anchoring and applications). Also, water from past roof leaks may have intruded into the cable jackets, which can deteriorate the integrity of the cable assemblies.

Figure EP15 - Example of improperly installed cables

Figure EP16 - Example of improperly installed cables

- e) **Branch Circuit Wiring and Cabling:** Damaged and aged branch circuit wiring should be identified and replaced. Existing conduits that are in good order can be reused wherever possible. All electrical work that was installed since the building were constructed should be closely reviewed and work not complying with NEC should be replaced using code-compliant means, methods and materials. All branch circuit power and communications cables that remain should be reviewed to ensure they are all installed using anchorage and supports that are not shared with other systems (i.e. they should not be strapped to conduit, equipment, etc. – they should have independent supports directly to structural elements). Power sources for the bay area overhead reel-cords should be checked to ensure they are fed from ground fault interrupter circuit interrupter (GFCI) type circuit breakers. Ground fault circuit interrupter protection should be reviewed for all applications required under NEC and GFCI protection should be provided for all instances where it does not already exist. All circuiting serving all living areas should be provided with arc-fault protection at each associated source circuit breaker. This will prevent an arcing condition inside an outlet box (or in cords, etc.) from starting a fire. Such arc-faults can create a great deal of heat without drawing enough current to trip a normal breaker.

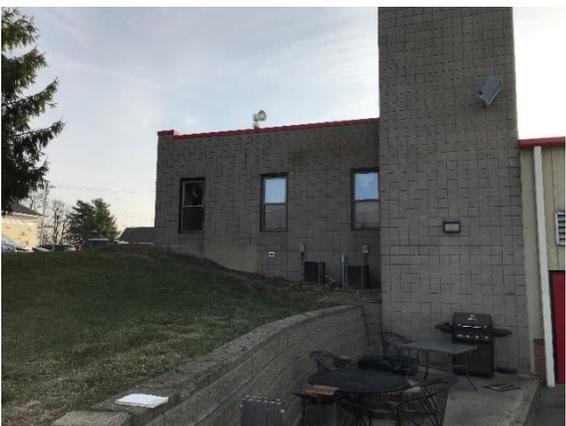
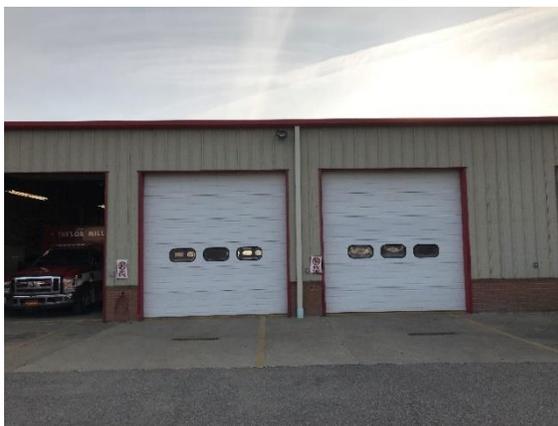
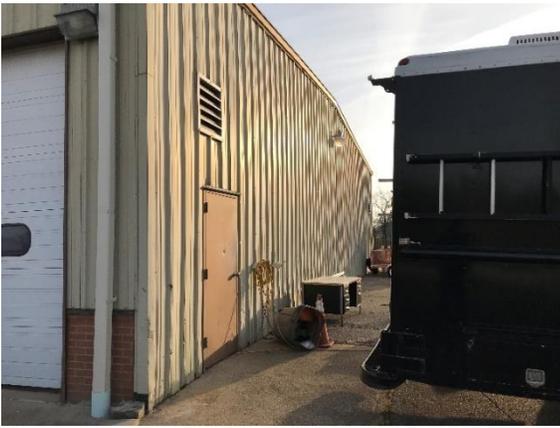
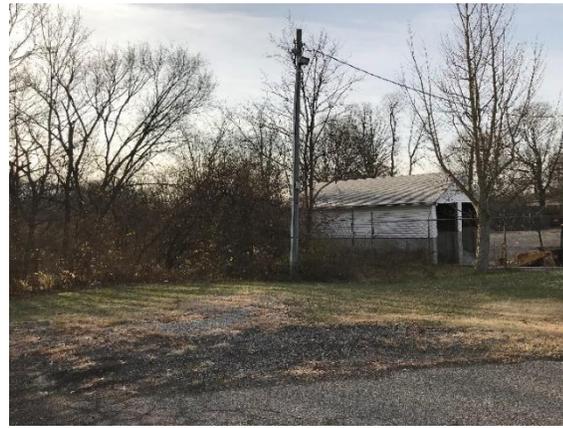
Outdoor Lighting: Exterior lighting is achieved using outdated high-intensity discharge (HID) building-mounted and pole-mounted flood lights and general area lights. Some outdoor lighting has been added over time to supplement the original conditions. These styles are prone to introducing glare and undesirable lighting onto adjacent properties. Some of the lights are approaching the end of their useful life.

Figure EL5 - Outdoor Lighting Example

Figure EL6 - Outdoor Lighting Example

Figure EL7 - Outdoor Lighting Example

Figure EL8 - Outdoor Lighting Example

- d) **Outdoor Lighting:** The site should be collectively studied, and a plan developed to replace all existing luminaires with new integrated-LED luminaires. The new lights should include full-cutoff optics, which are easier on the eyes and minimize introduction of glare on adjacent properties. Placement, mounting heights and distribution optics should be selected for optimal functionality and security needs along with ideal light distribution, while minimizing luminaire quantities and light spill. This recommendation includes some new lighting standards with one or two luminaires per pole.

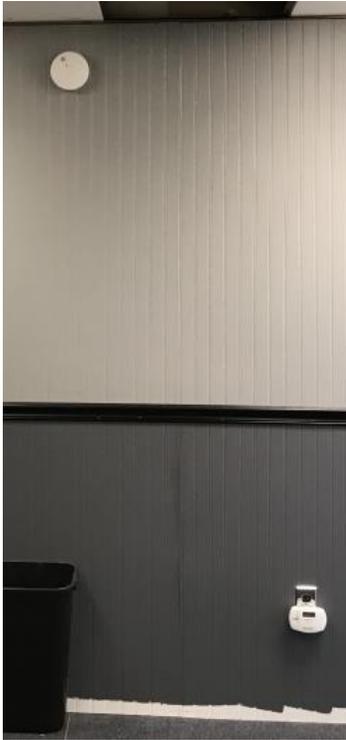
The facility is not equipped with a central comprehensive fire alarm system. There are various stand-alone (some may be tandem wired) fire alarm and carbon monoxide (CO) devices installed.

Figure FA1 - Smoke alarm unit (high) & CO alarm unit (low)

A central system would include smoke detection, heat detection, monitored CO detectors, manual pull stations, notification appliances (horn/strobes) throughout, battery and generator backup and digital communicator to a Central Station monitoring facility and to selected phone numbers in the event of a fire. Such a new system would not be zoned, it would be fully addressable with each alarm-initiating device assigned a unique address and annunciation. A new state-of-the-art system could also be used to help educate fire fighters on how contemporary systems operate.

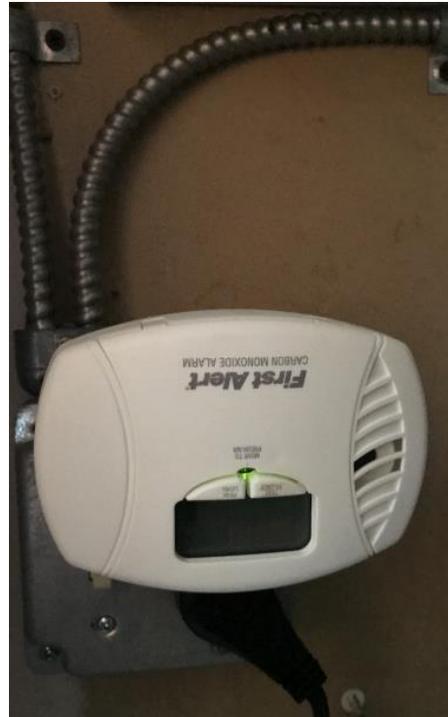
Figure FA2 - CO alarm unit
