Facility Assessment

Fire Station Building #1

Prepared for
the City of Taylor Mill, Kentucky

January 5, 2021

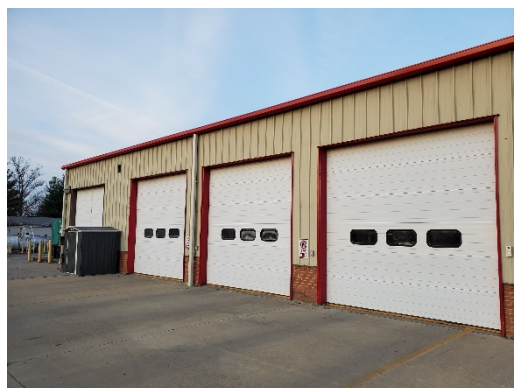
2 |

The 4,900 square foot +/- single story rear section of the building consists of four structural bays constructed of steel beams, columns, and metal siding that are supported by a concrete foundation. There is a low wainscot of brick over concrete block on either side of the overhead doors. The upper portions of the walls and the roof were insulated with fiberglass bats in the manner of pre-engineered metal buildings with a plastic liner. The floor is poured concrete. The first three bays are in use as apparatus bays. The fourth bay is separated from the rest with a full height concrete block wall installed when the water department utilized that area. Within the last few years, this bay has been repurposed as a fitness center and storage room.

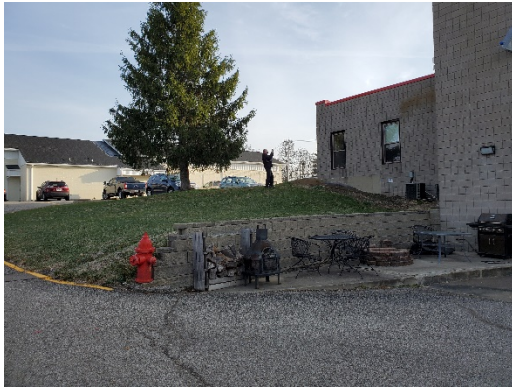
4 |

It was reported that the original fill on this site was not well compacted. This is supported by various cracks observed in the concrete as well as the condition of the building to be discussed later.

It was reported that storm water flows down the grassy slope and ponds on the concrete in front of apparatus bay 4, despite the trench drain.

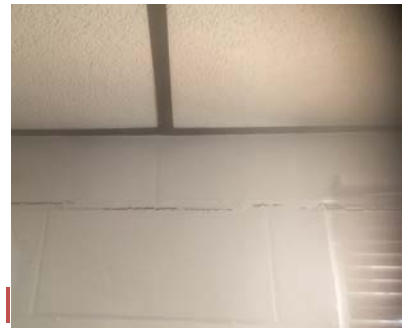
12

Steel lintels above the exterior doors and windows were observed to have a significant coating of rust (corrosion). See photos 10, 11, & 13. The expanded volume of these lintels has separated the mortar joint between the course below and course above the lintel extending around the structure, which allows water to get into the wall. In places, this separation is also observed from the inside.

Recommendation	Estimated cost
1	Remove and replace all of the corroded door and window lintels.	\$ 18,300
2	Install retrofit brick ties to connect the exterior concrete block to the interior concrete block.	\$ 15,400
3	Repoint masonry joints in the Office/Living section of the facility.	\$ 30,000
4	Apply a sealer to the entire exterior concrete block surface. Please note that this must be re-sealed every five years.	\$ 9,600
5	Underpin the Office/Living section of the building to minimize future settlement.	\$ 57,000
6	Replace concrete slabs along front of building and in apparatus room after underpins are installed.	\$ 4,800
7	Connect a steel angle to the west exterior wall and then install steel straps to connect the angle to several roof joists.	\$ 8,500
8	Remove wall finishes from upper level exterior walls, including the rusted metal furring strips and insulation. Replace with fiberglass furring, polyisocyanurate insulation boards, mold & moisture resistant gypsum board and plastic corner beads. Repaint. Install new base to match existing elsewhere in rooms.	\$ 14,000

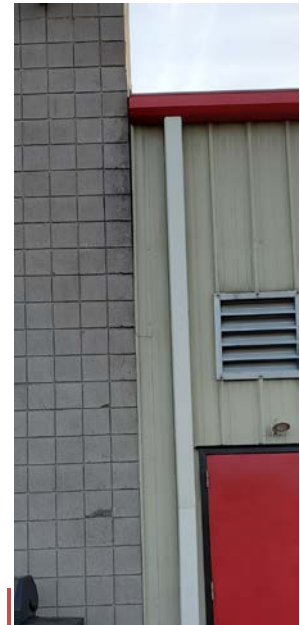
18

In a few locations, the brick is chipped or cracked. Inside corners exhibit separation. See photos below. The Apparatus Bays and the Office structure are separating above the upper floor line. Rust staining is visible in one area.

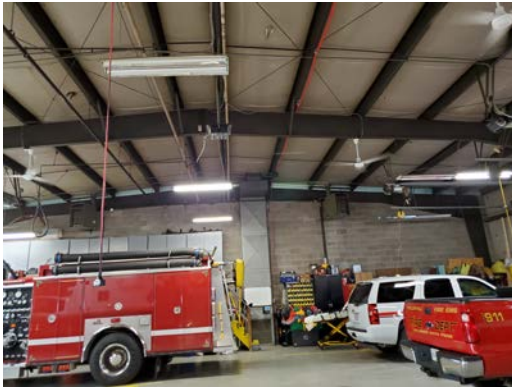
23

Condition: The Apparatus bays are in good condition. In three locations, deterioration of the lower two courses of concrete block were observed. See photo 24. These were near overhead doors where daylight was visible through gaps between the doors and frames at the base. This could allow moisture in the block to freeze and spall the inside surfaces.

Hairline cracks were observed in the concrete floor in most bays. No vertical offsets were observed. These are likely due to insufficient control joints in the slab.

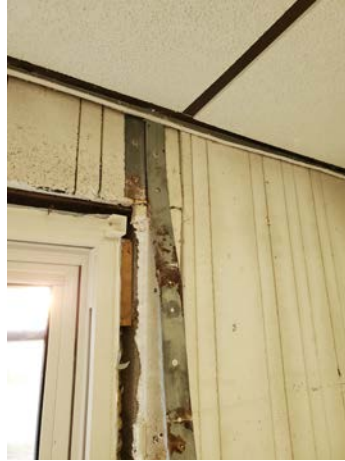
33

The finished drywall has been removed from the upper level Break Room exposing the insulation and rusted furring strips. The ceiling grid shows horizontal movement (bowing) of the exterior wall. Many other upper level rooms exhibit irregularities in the paint surfaces at the window returns, suggesting corroded corner beads. A few windows show cracks emanating from the upper corner of the window.

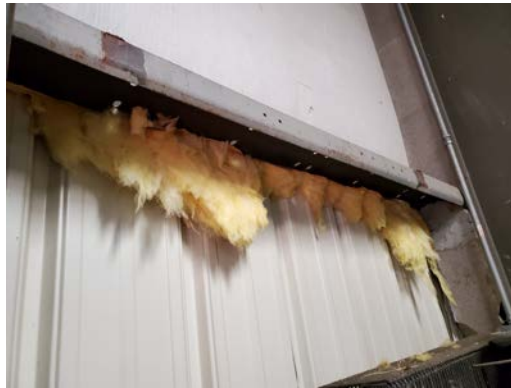
37

The condition of the Apparatus Bays is satisfactory. Light was observed between the wainscot and wall sole plate in one location and some of the wall insulation is damaged or missing. The concrete block separation wall between the Apparatus Bays and the current Fitness room is in good condition as is the insulation and firestopping sealant above the structural frame to the roof.
