TECHNICAL MEMORANDUM

TO: Sean Blake, P.E., Sanitation District No. 1 of Northern Kentucky

FROM: Richard W. Carr, P.E., Mason Carr Civil Engineering, LLC

RE: Vincent Drive, Taylor Mill, KY Drainage Improvements Technical Assistance

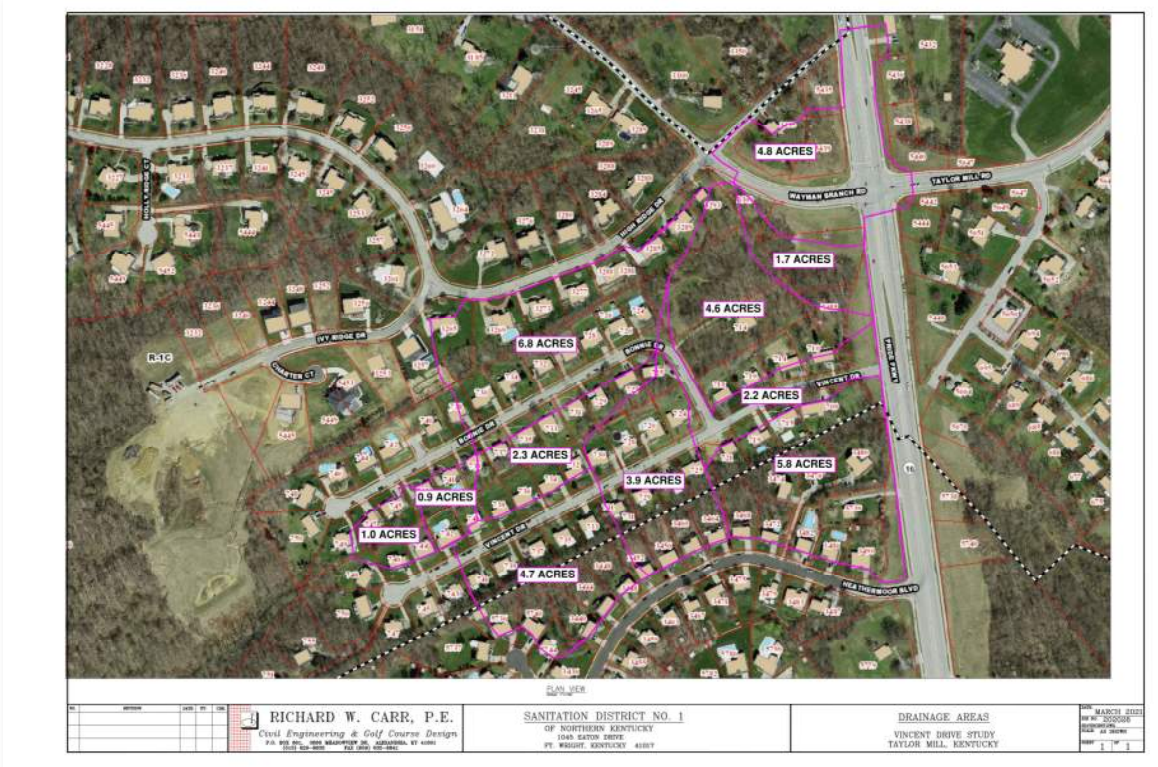
Figure 2 – Delineation of drainage areas

In addition to on-site field investigation, Mason Carr reviewed GIS maps, SD1 maps, and the SD1 drainage folder containing information from the construction of Pride Parkway. Mason Carr demarcated the drainage areas associated with the flooding issues at Vincent Drive by focusing on the area from the headwall that empties into the existing creek at 748 Vincent Drive through the paved channel behind 716 Vincent Drive and to the intersection of Pride Parkway and Wayman Branch Rd. By separating out each of these drainage areas, Mason Carr was able to assign a land use assessment to each of the areas and distinguish between the pervious (grass, woods, etc.) and impervious areas (roadways, sidewalks, driveways, rooftops, etc.) associated with each of these drainage areas. Distinguishing between these pervious and impervious areas allows a storm water runoff model to be developed and evaluated in order to view the effect that various conditions have on the storm water in the area including pre- and post- construction activities. Table 1 below summarizes the drainage areas and impervious areas contributing to each, Figure 2 shows a map view of these delineated drainage areas, and Figure 3 shows a map view of the impervious areas.

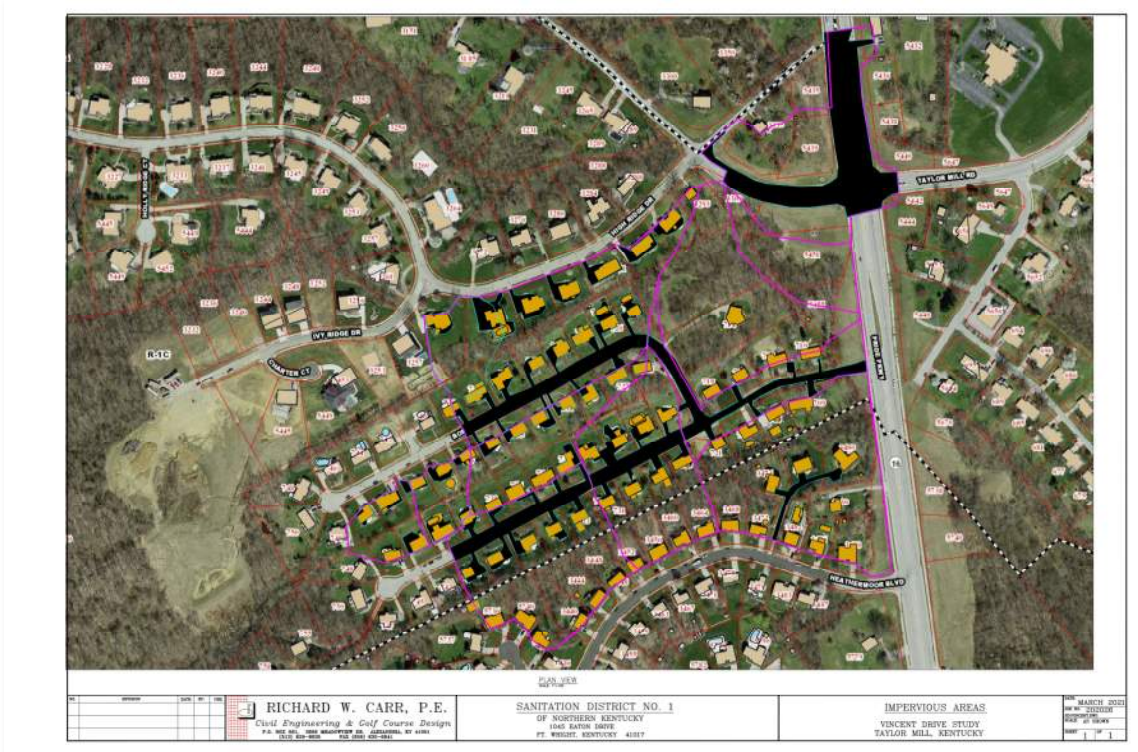
Figure 3 – Delineation of drainage areas – Impervious

The total drainage area contributing stormwater flow to this location is 38.7 acres with 10.5 acres of that area being impervious surfaces. The drainage area that discharges into the creek at the bottom of the 748 Vincent Drive property discharges through the headwall pictured in Figure 3.

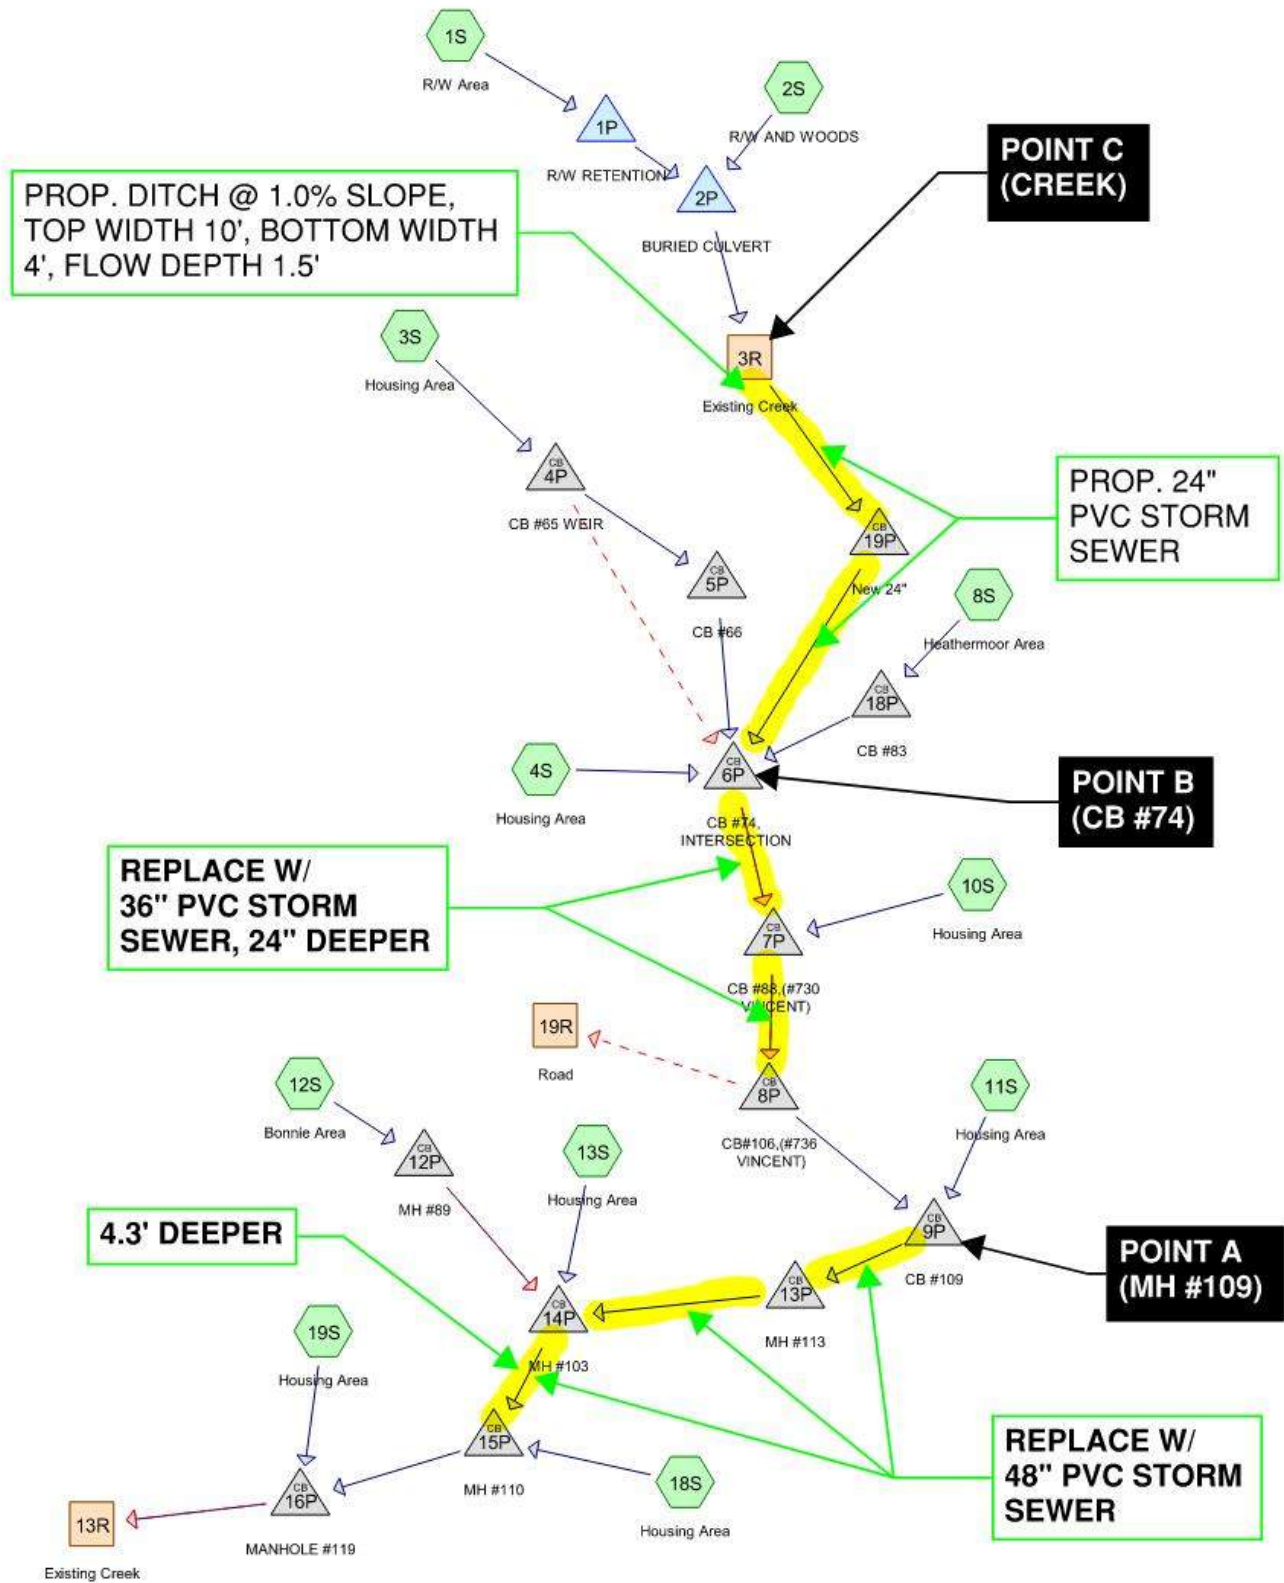
Figure 12– Diagram of Stormwater Model – Alternative 1

The stormwater model referenced above in Figure 12 was used to analyze Alternative 1 and the overall capacity of the existing storm sewer system in the area designated for this study. Table 4 below shows a comparison of the maximum water depths at the “control” points for the existing system and the new system suggested in Alternative 1. The values in Table 4 represent the elevation of the Hydraulic Grade Line (HGL) minus the rim elevation of the corresponding storm structure (or the floor elevation of the nearby houses in the case of Point C). Thus, a positive value corresponds to a flood condition; whereas, a negative value corresponds to the water level being below the flood condition.

In order to analyze the potential reduction in flooding risk associated with the improvements describing in Alternative 1, a new stormwater model was developed using these new parameters. The model for Alternative 1 is shown below in Figure 12:

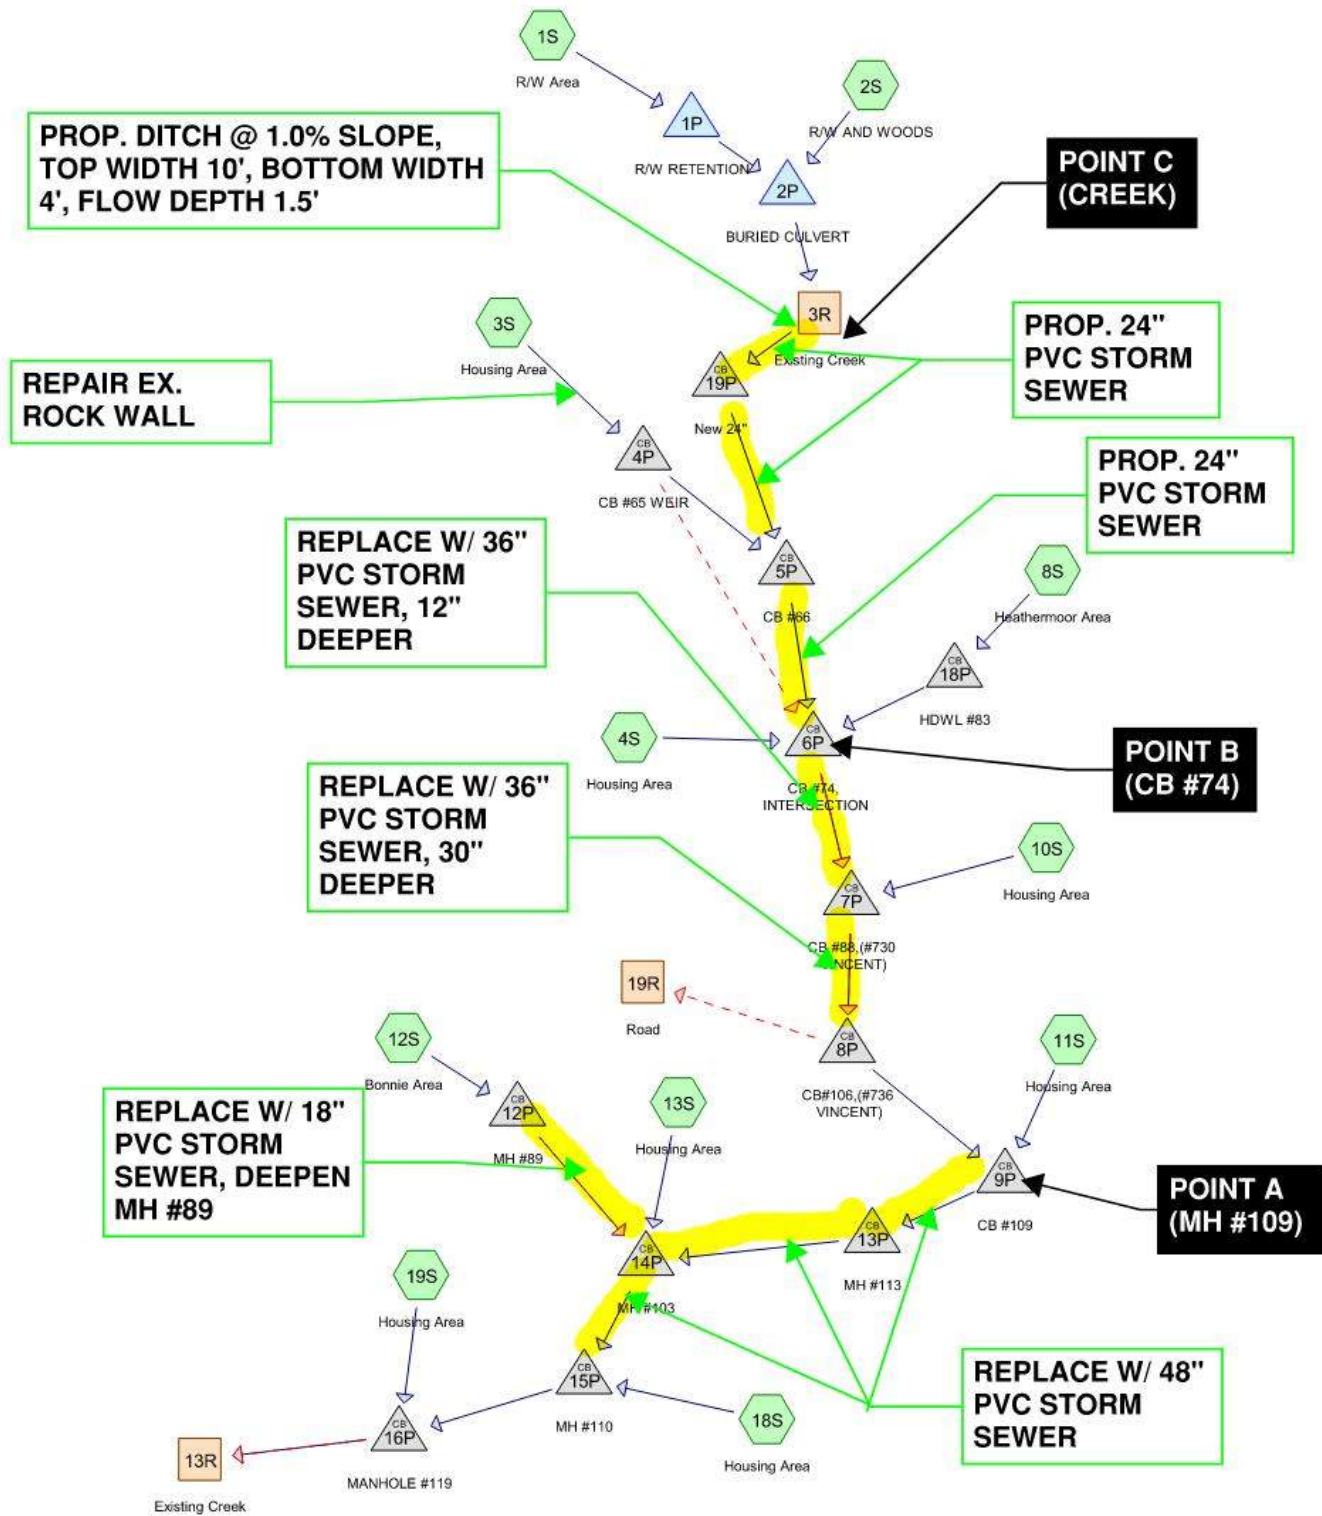
Figure 14– Diagram of Stormwater Model – Alternative 2

The stormwater model referenced above in Figure 14 was used to analyze Alternative 2 and the overall capacity of the existing storm sewer system in the area designated for this study. Table 5 below shows a comparison of the maximum water depths at the “control” points for the existing system and the new system suggested in Alternative 2. The values in Table 5 represent the elevation of the Hydraulic Grade Line (HGL) minus the rim elevation of the corresponding storm structure (or the floor elevation of the nearby houses in the case of Point C). Thus, a positive value corresponds to a flood condition; whereas, a negative value corresponds to the water level being below the flood condition.

In order to analyze the potential reduction in flooding risk associated with the improvements describing in Alternative 2, a new stormwater model was developed using these new parameters. The model for Alternative 2 is shown below in Figure 14:

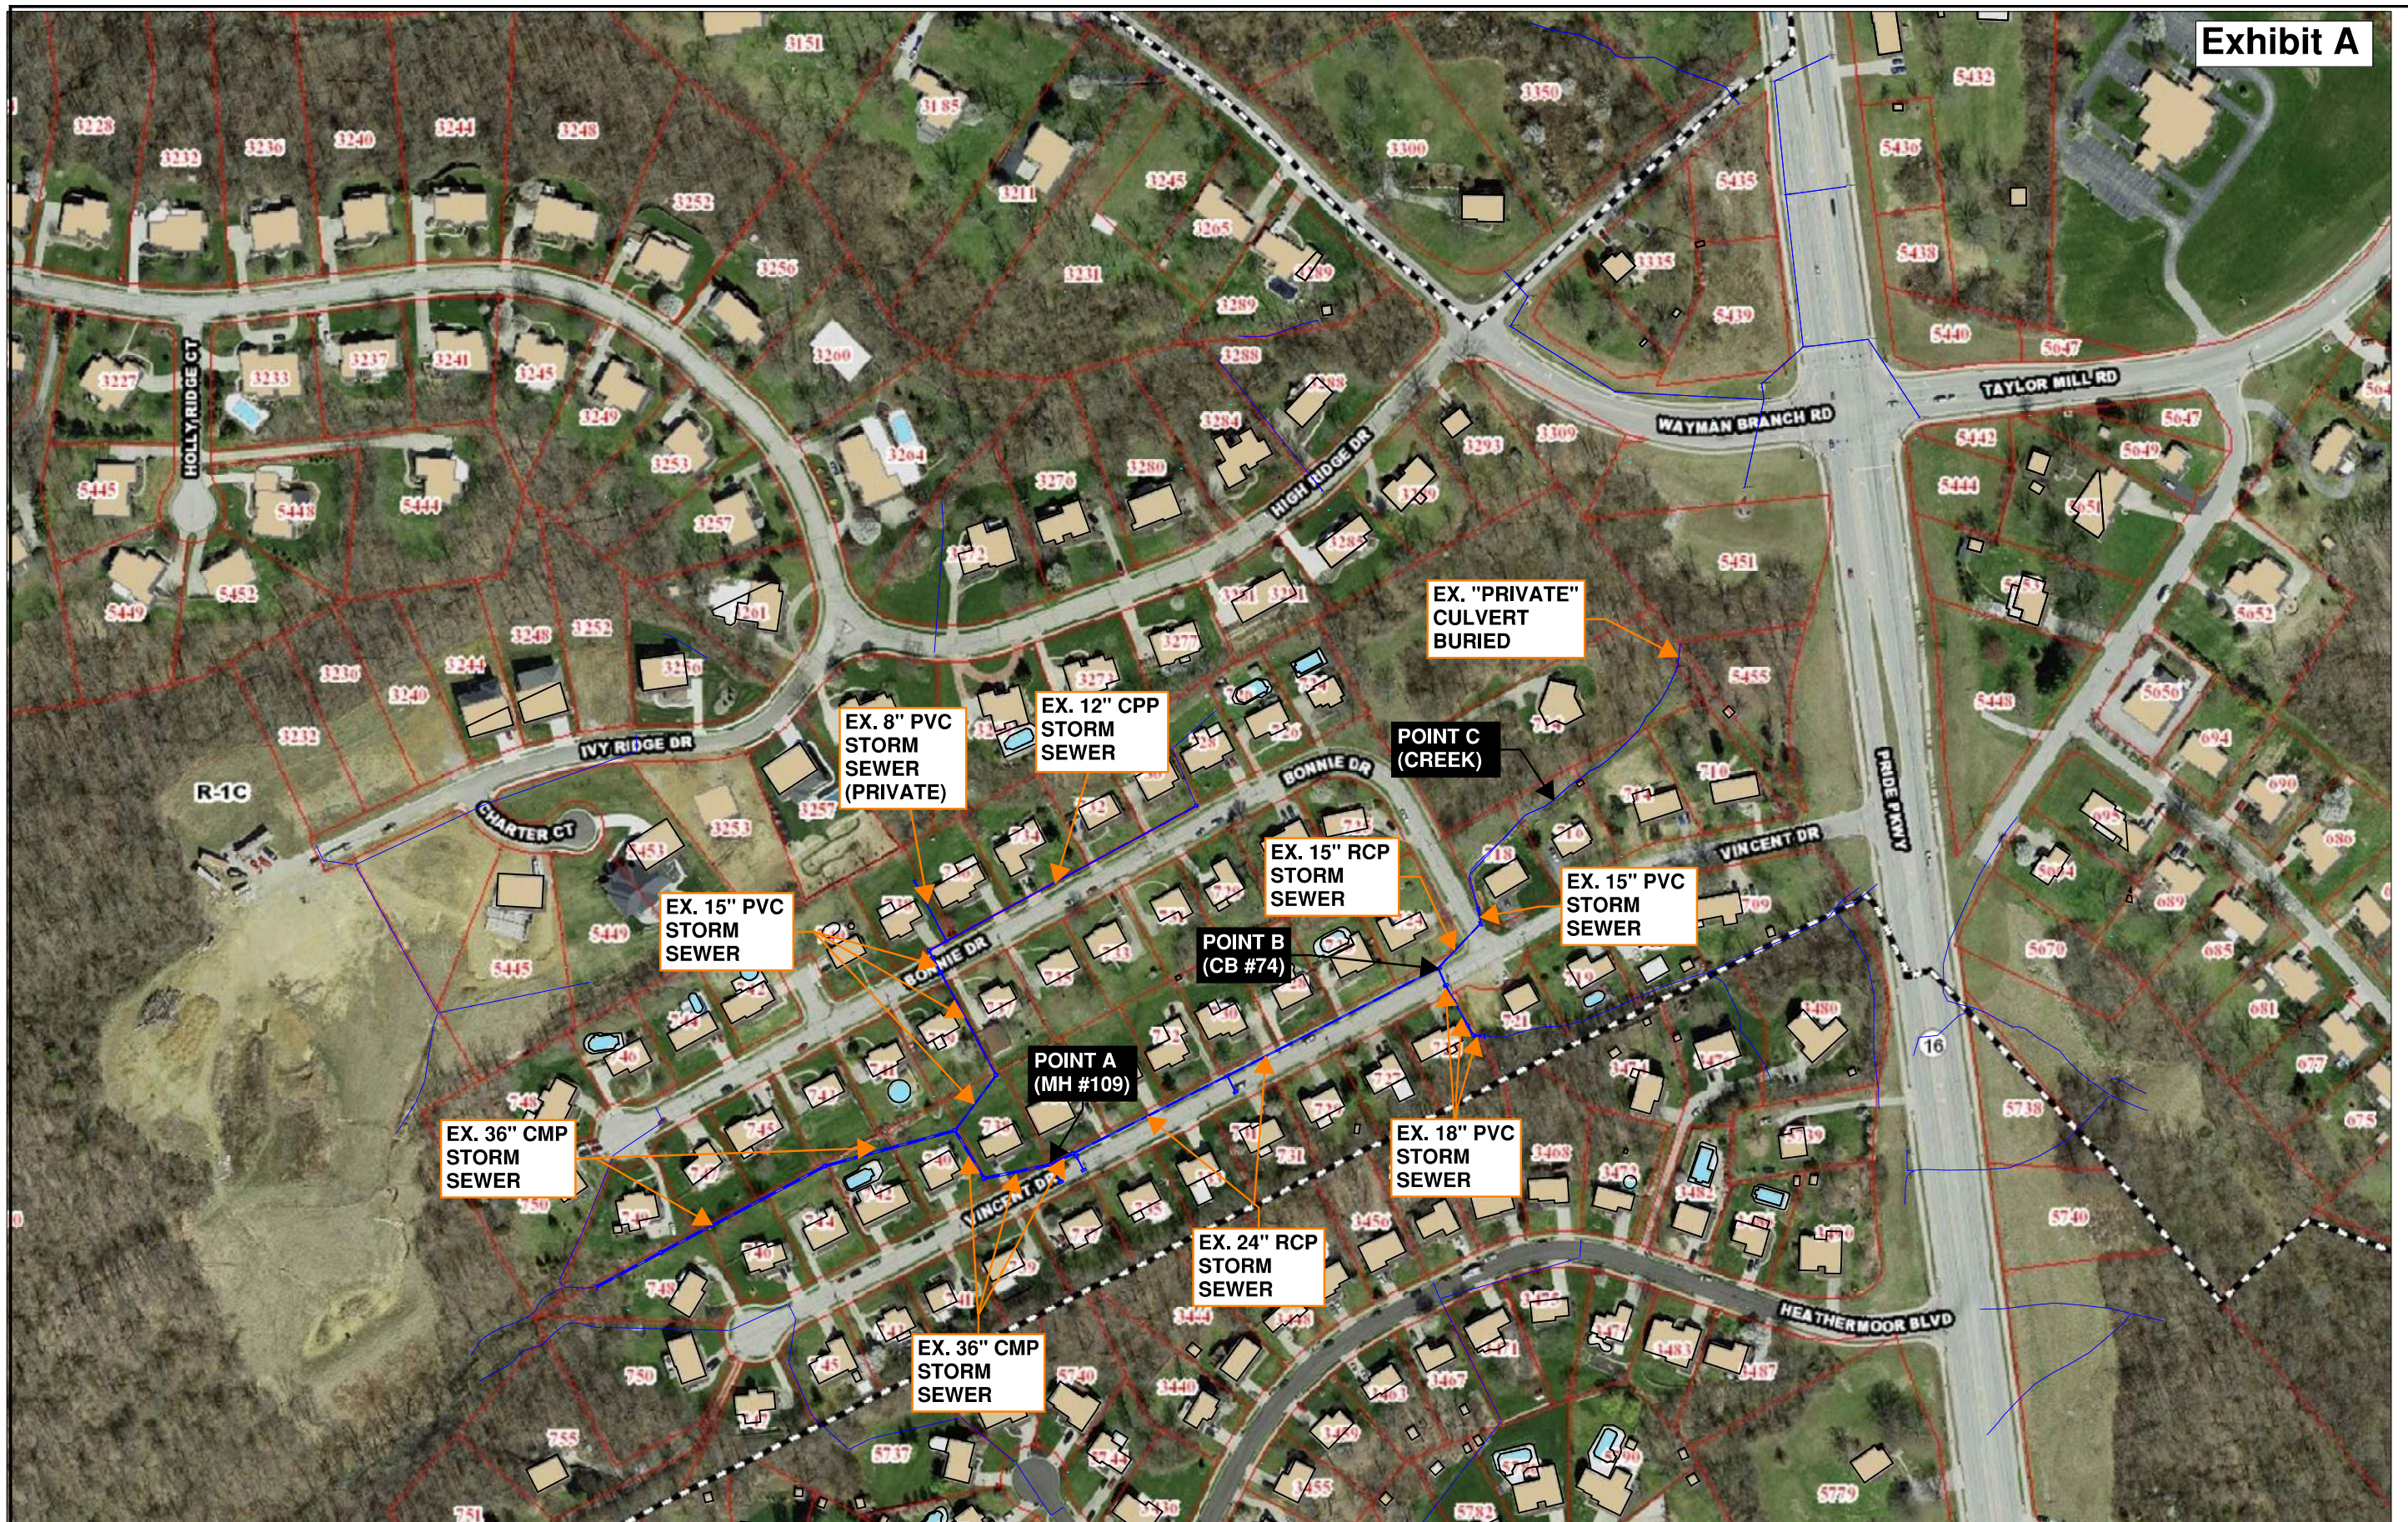
EXISTING CONDITIONS
 VINCENT DRIVE STUDY
 TAYLOR MILL, KENTUCKY

The roadway flooding near 736 Vincent Drive is the result of several factors. The street grades and lot grading created a “sag” condition in the subdivision. The condition is worsened by upstream street drains allowing flows to pass-by due to resurfacing and pavement reconstruction. The direct drainage area into the “sag” is approximately 4.7 acres with over half of that from the uphill Heathermoor Subdivision. The total drainage area into the “sag” area is approximately 28 acres. During storm events in recent years, residents have reported flooding that has occurred on the street as deep as 18” for short periods. Residents indicate the flooding lasts for 5 to 10 minutes.
